2024 Inspection Summary

City of Kenora Bridges	BCI	City of Kenora Bridges	BCI
Bay Street Overpass	60.46	Matheson Street Bridge	70.39
Beggs Road Timber Bridge	69.68	Mink Bay Pedestrian Bridge	88.77
Beggs Road Arch Culvert	88.47	Norlen Bridge	86.91
Cameron Bay Bridge	81.99	Parson Street Bridge	68.27
Coker Road Bailey Bridge	98.42	Portage Bay Bridge	64.48
CPR Pedestrian Bridge	77.99	Portage Bay Walkway Bridge	71.39
Darlington Bay Bridge	75.07	Portier Bridge	72.75
Eighth Avenue Bridge	79.15	Seventh Avenue South Bridge	97.18
First Avenue Bridge	72.36	Winnipeg River East Branch Bridge	84.04
Keewatin Channel Bridge	70.85	Winnipeg River West Branch Bridge	73.53
Lajeunesse Bridge	71.19

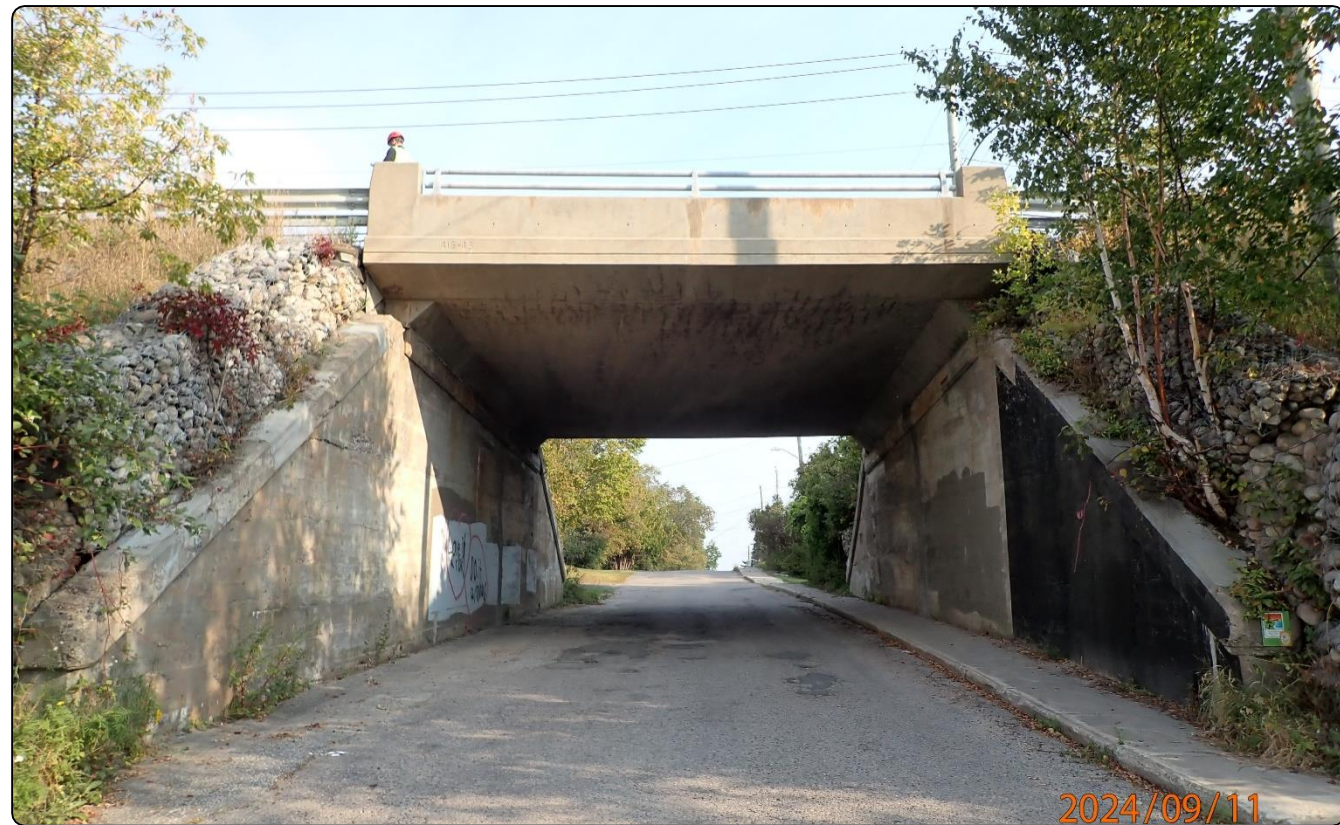
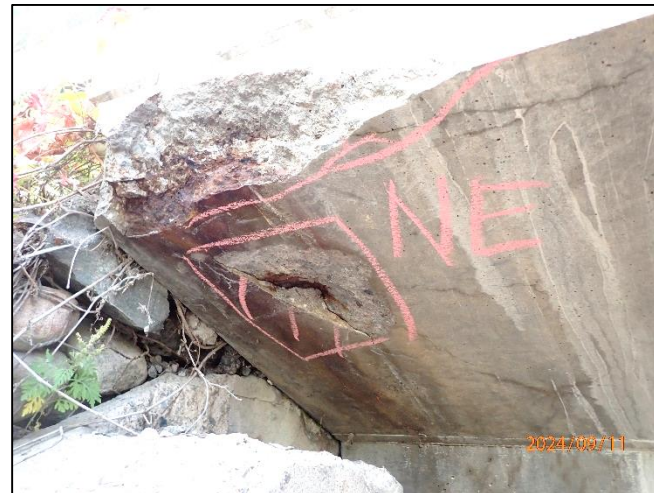
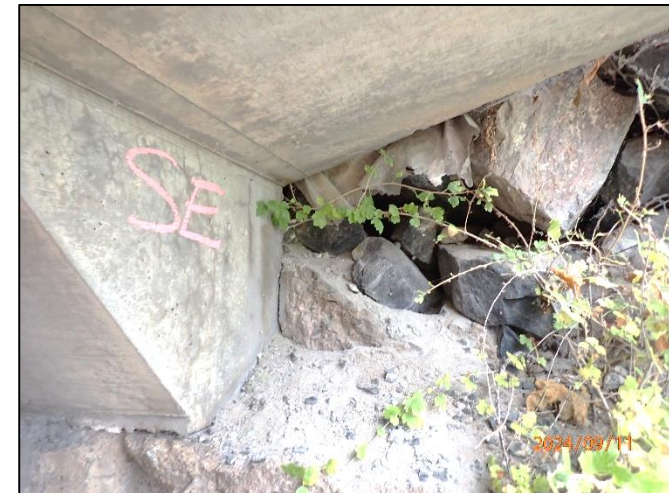
BAY STREET OVERPASS

- Abutment Walls
 - Wide cracks and delaminations
- Ballast Walls
 - Exposed on ends, SE missing retainer with loose rock
- Deck Soffit
 - Delaminations at corners exposing corroded reinforcement

**Complete
Maintenance**

\$35,000

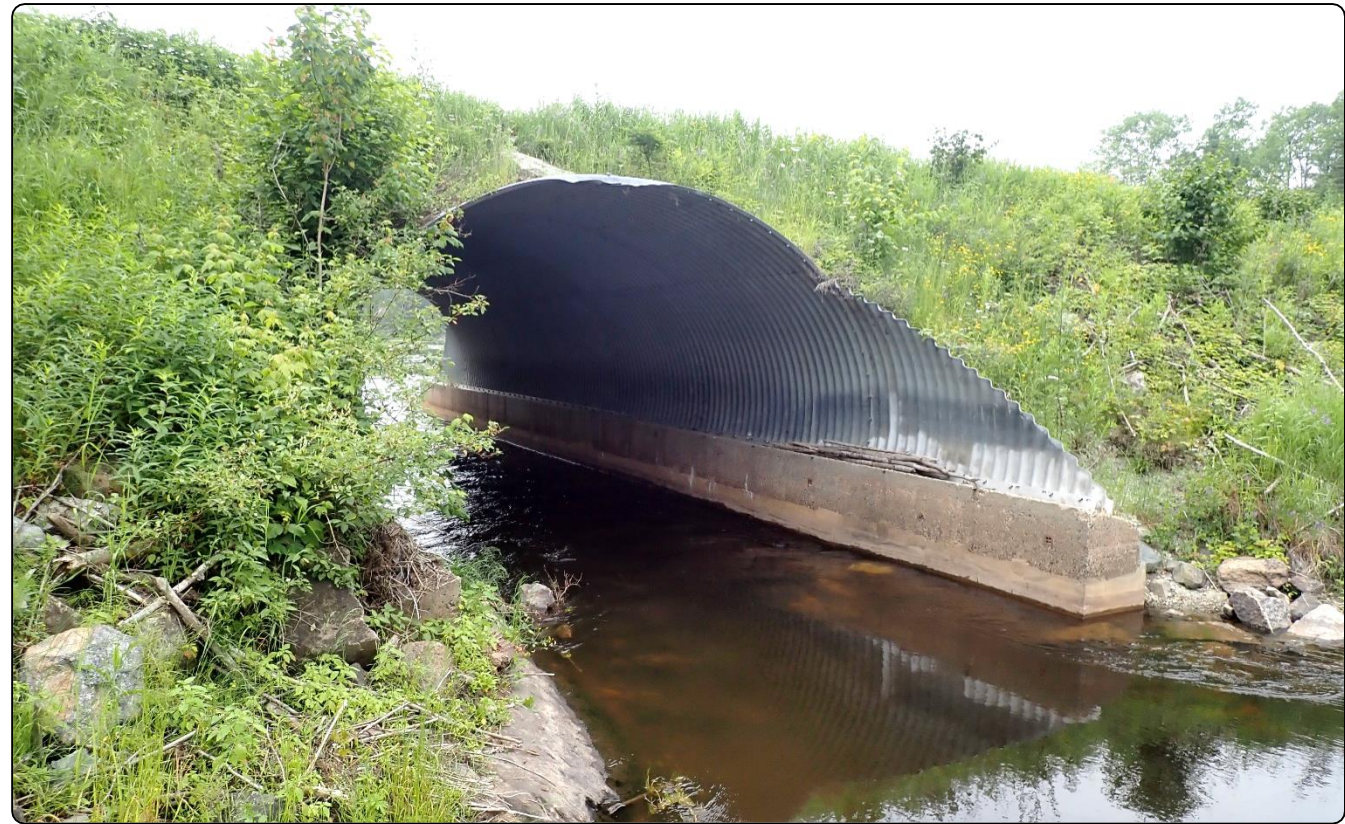
BEGGS ROAD ARCH CULVERT

- Abutment Wall - North
 - Isolated vertical medium to wide crack at center of barrel
- Abutment Wall - South
 - Erosion and construction joint
- Culvert Barrel
 - Isolated deformation at inlet soffit

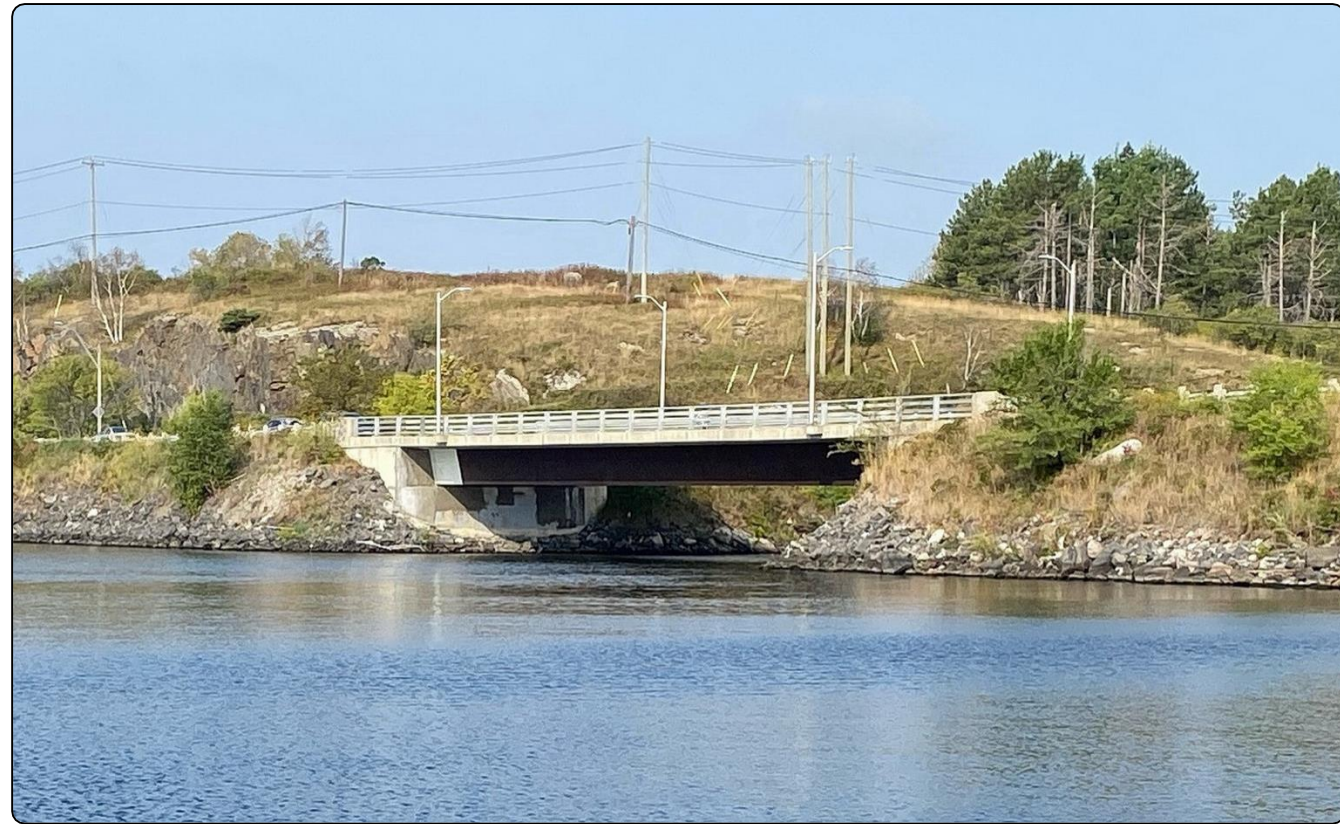
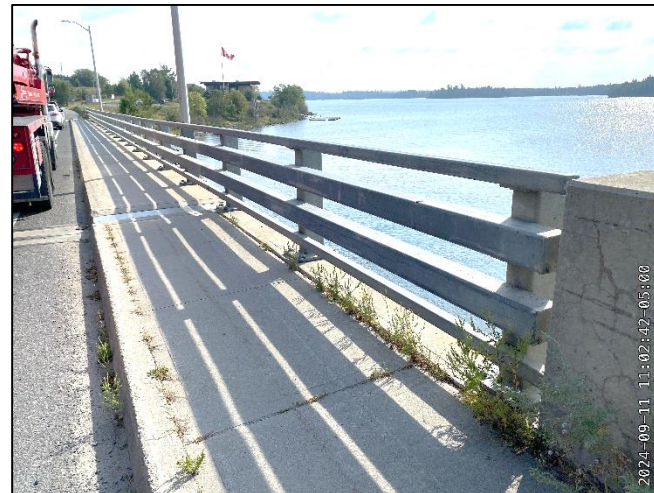
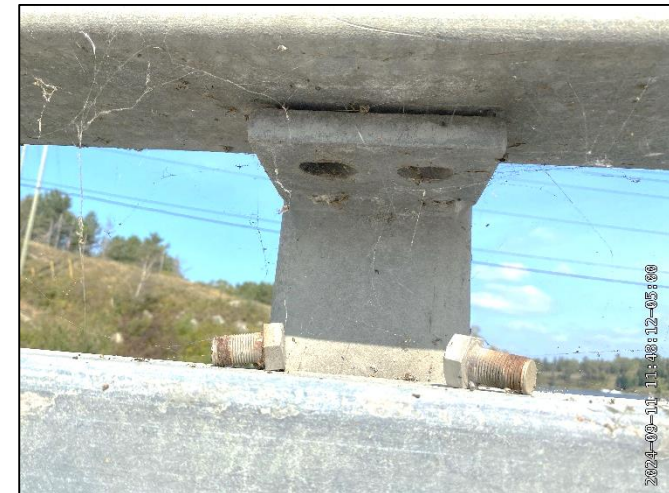
CAMERON BAY BRIDGE

- Approach Sidewalks
 - Vegetation growth
- Barriers - Posts
 - Missing and loose bolts connecting the railing
- Joints
 - Joints filled with gravel

**Complete
Maintenance**

\$4,000

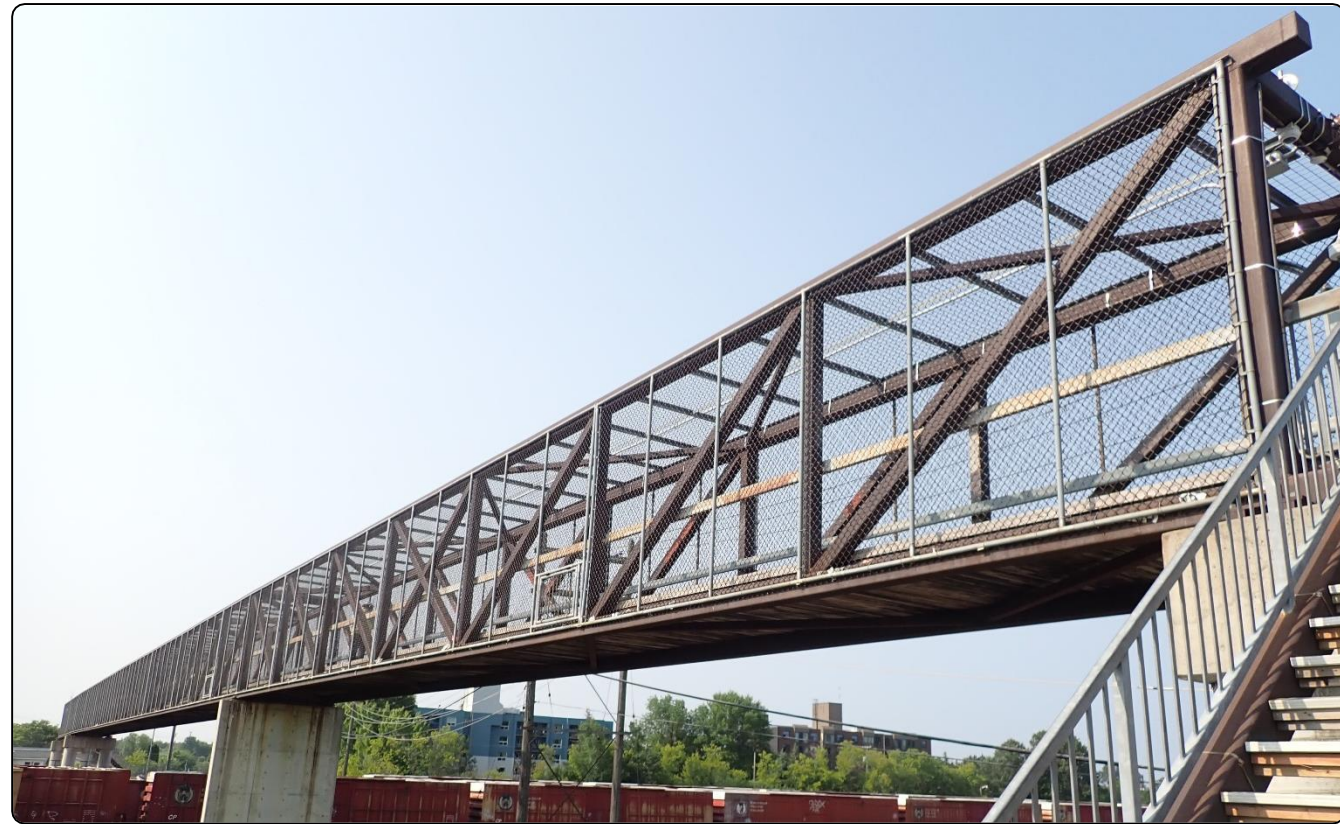
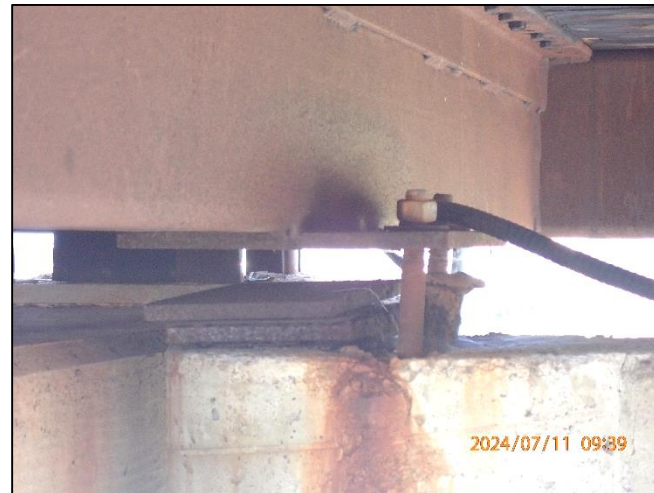
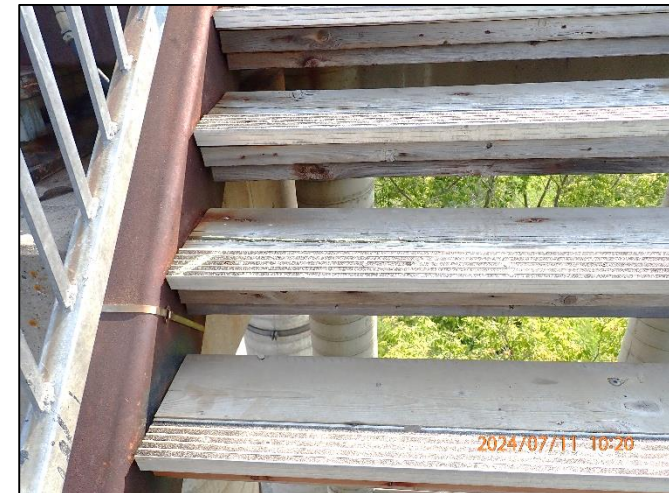
CPR PEDESTRIAN BRIDGE

- Approach Access Stairs
 - Majority of treads are loose and angled downwards due to:
 - Rust packing in support channels
 - Isolated rot with missing bolt connections
 - Isolated splits
- Piers – Bearings – Third Platform on North App.
 - Missing steel plates

**Complete
Maintenance**

\$126,600

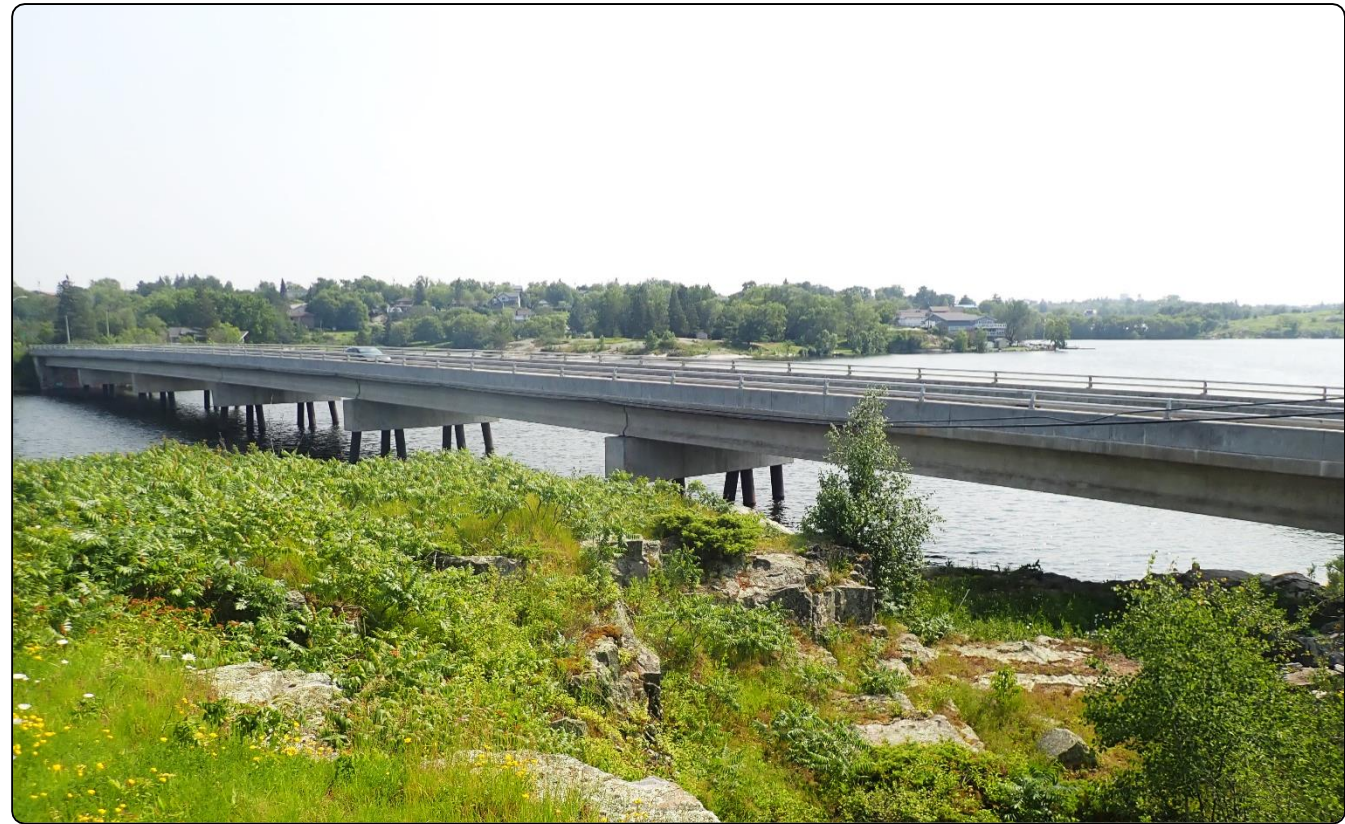
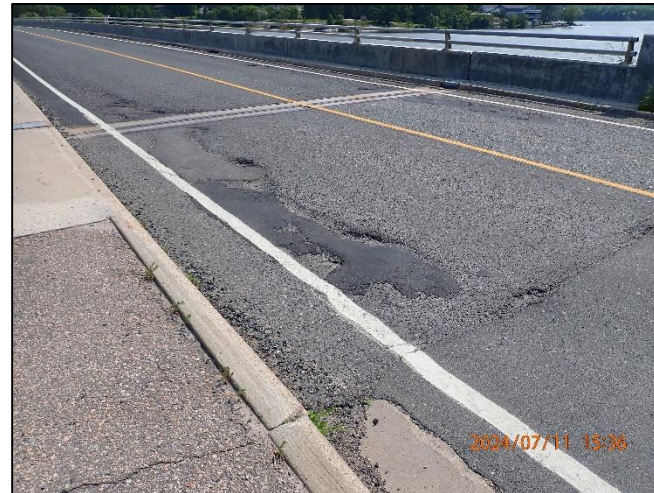
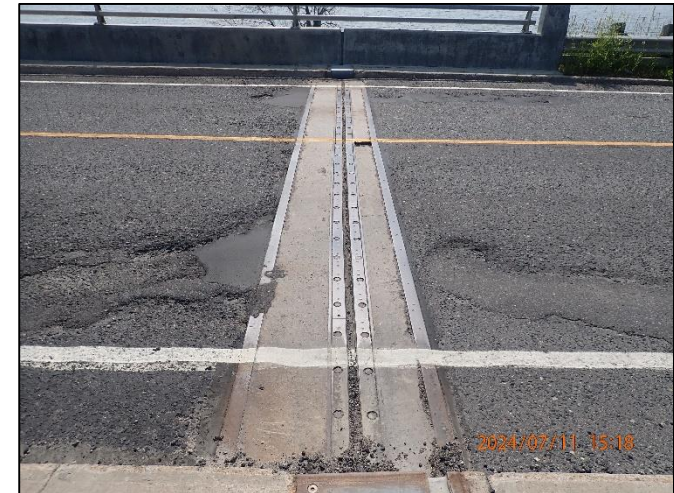
DARLINGTON BAY BRIDGE

- Approach & Deck – Wearing Surfaces
 - Isolated severe potholes
- Joints
 - Debris and gravel in joints

Complete
Maintenance

\$2,600

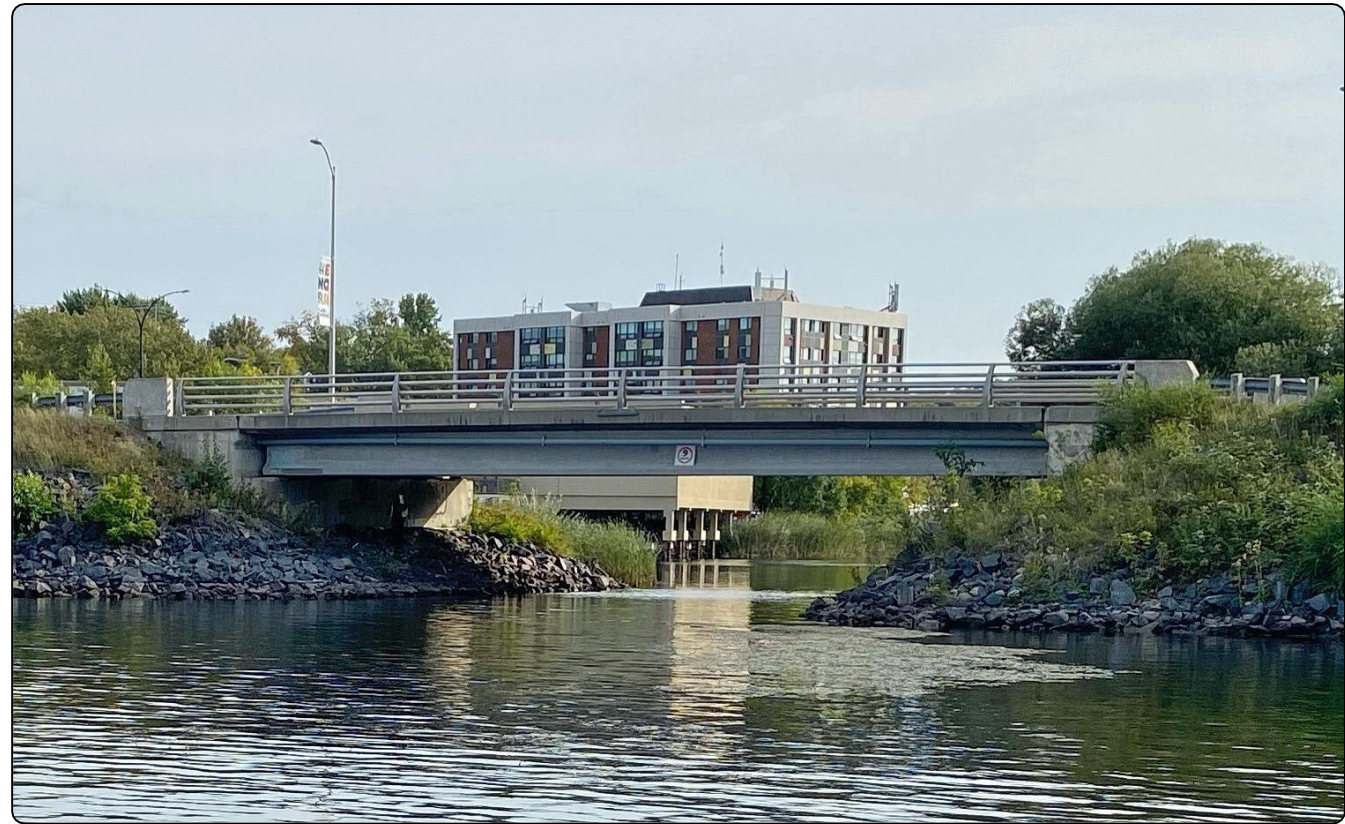
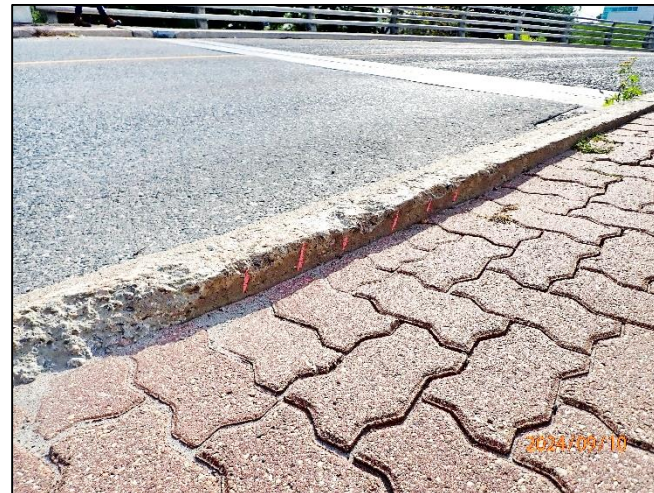
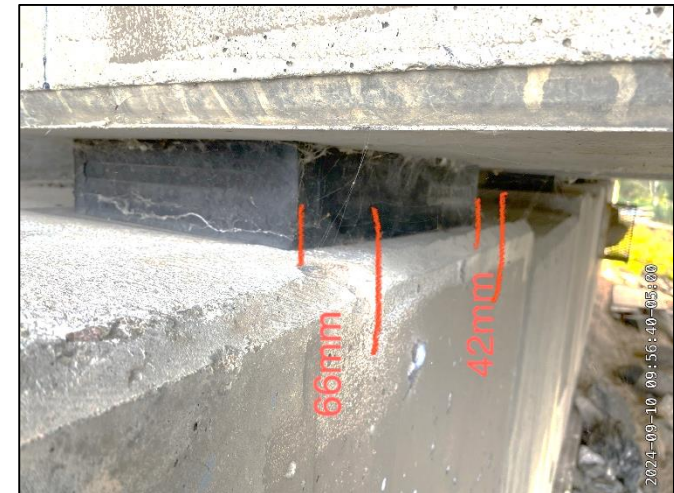
FIRST AVENUE BRIDGE

- Approach - Sidewalk
 - Settlement of interlocking bricks
- Signs
 - Missing Bylaw sign and No Wake sign
- Joints
 - Isolated bolt missing on armouring
 - Seals are leaking
- Embankments
 - Vegetation growth on NE concealing signage
- Abutment - Bearings
 - Abutment 1 B7 is starting to walk out

Complete Maintenance

\$26,000

Monitor next inspection

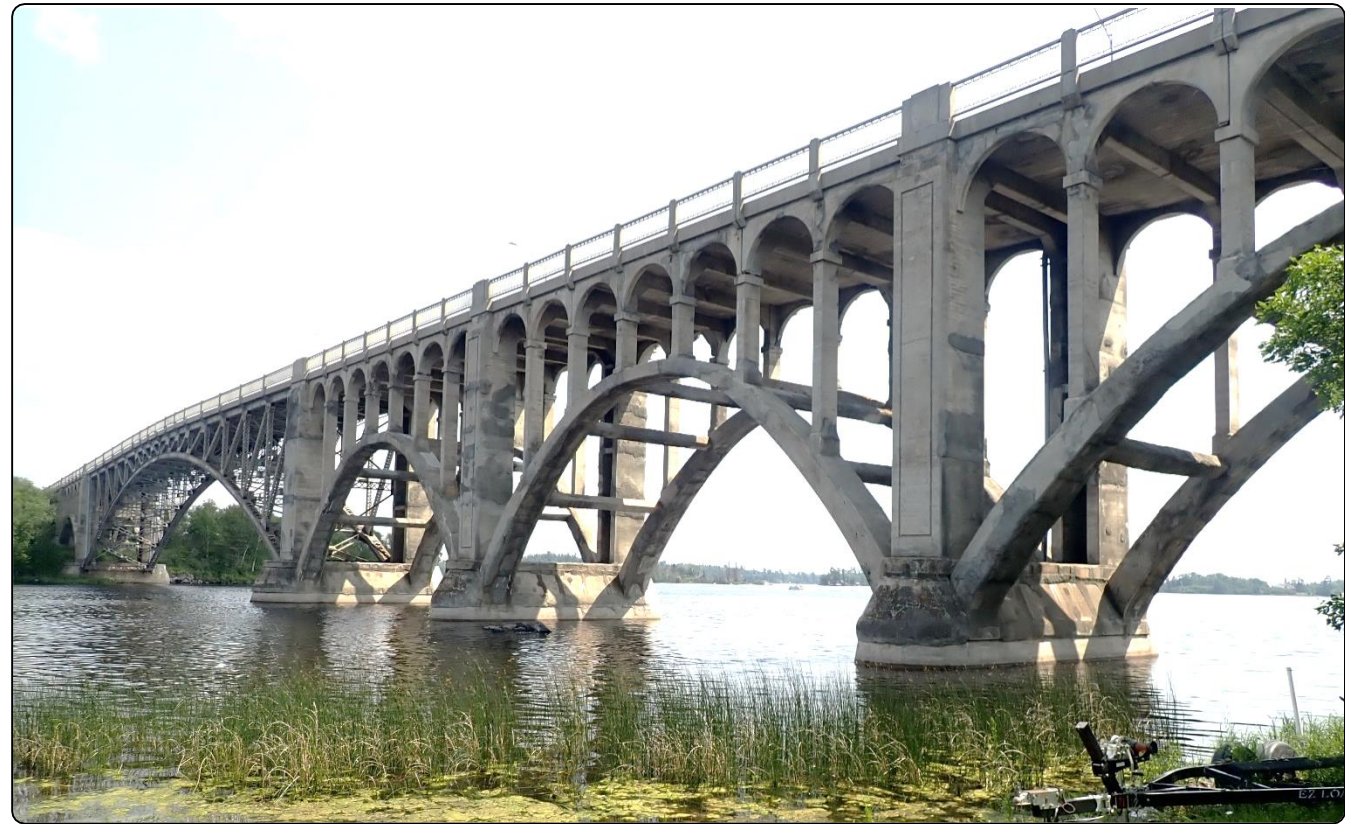
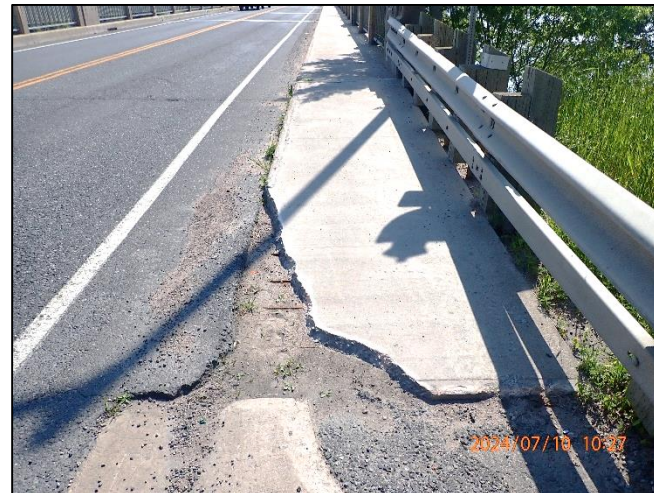
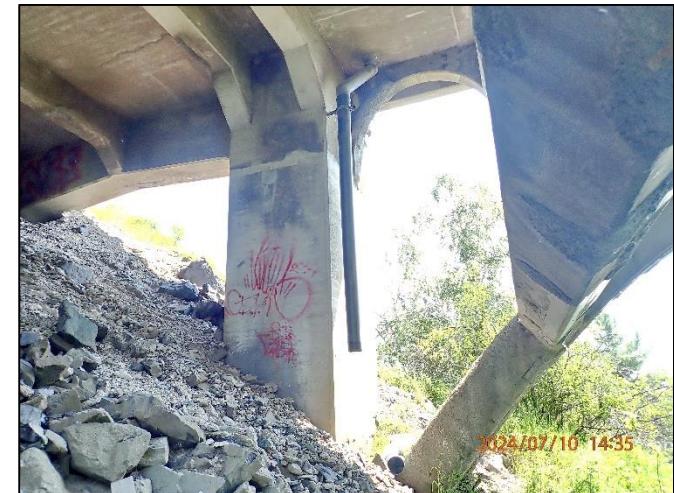
KEEWATIN CHANNEL BRIDGE

- Deck - Drainage
 - Isolated detached and broken drain connections
- Coatings – Structural Steel
 - Coating loss and intercoat delamination throughout truss arch elements
- Abutments
 - Used drug needles throughout
- Approaches - Sidewalk
 - Disintegration exposing corroded reinforcement at SW sidewalk

Complete Maintenance

\$5,006,500

Steel recoating addressed under separate contract

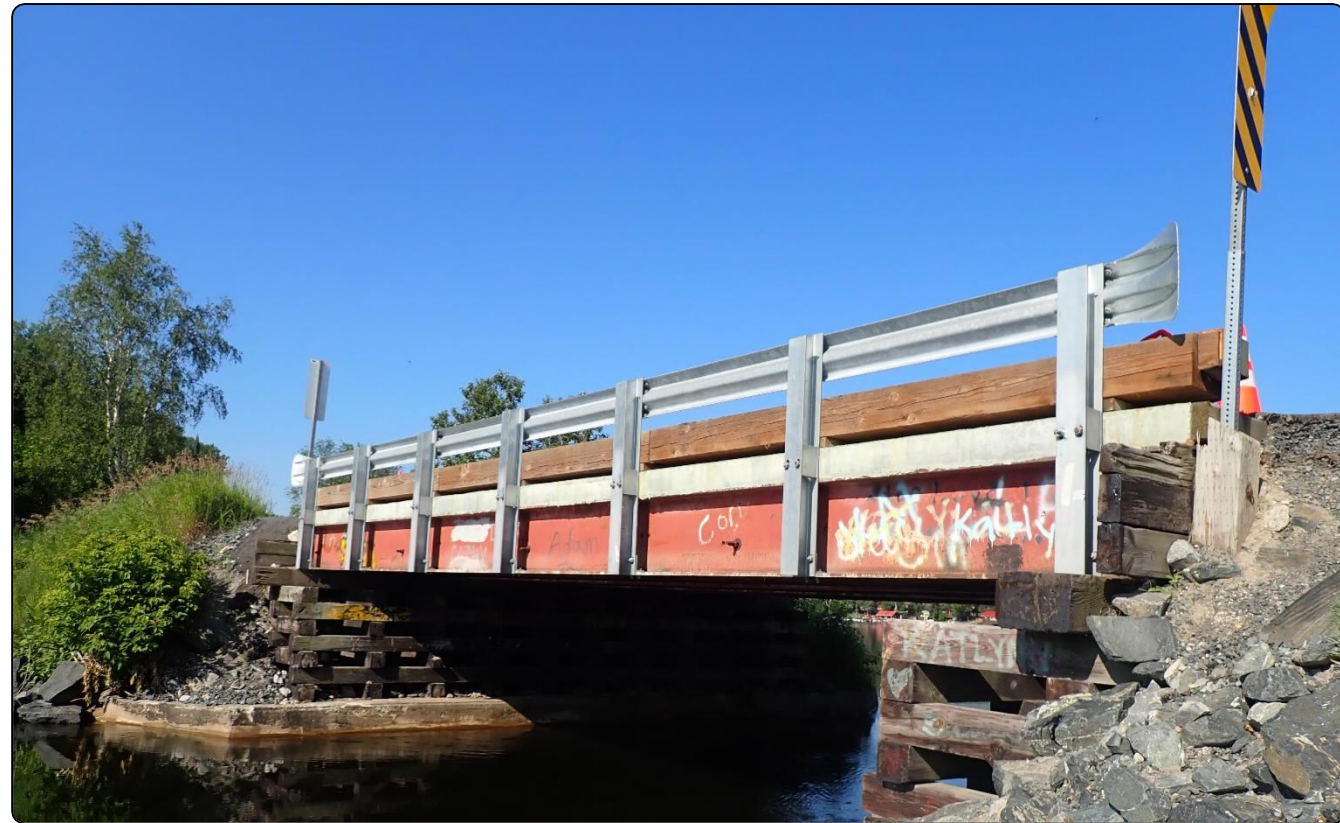
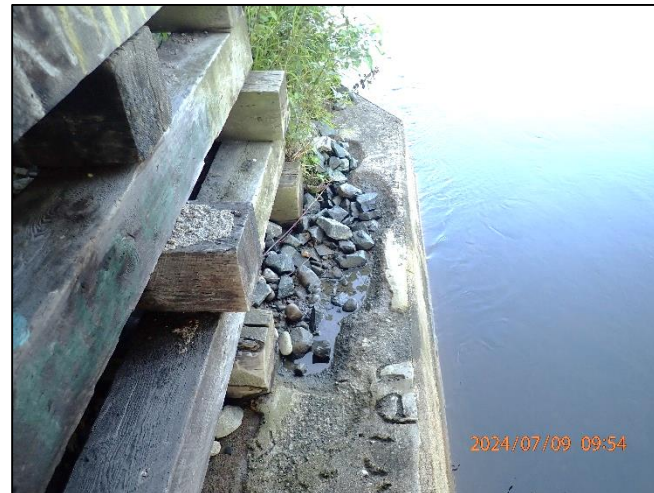
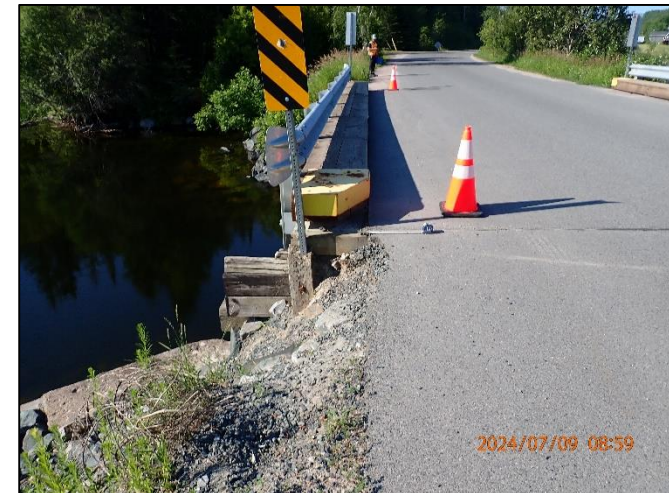
LAJEUNESSE BRIDGE

- Abutment Footings
 - Severe spalls and disintegration with isolated areas exposing corroded reinforcement
- Approaches – Wearing Surface
 - NE embankment material loss starting to encroach the roadway

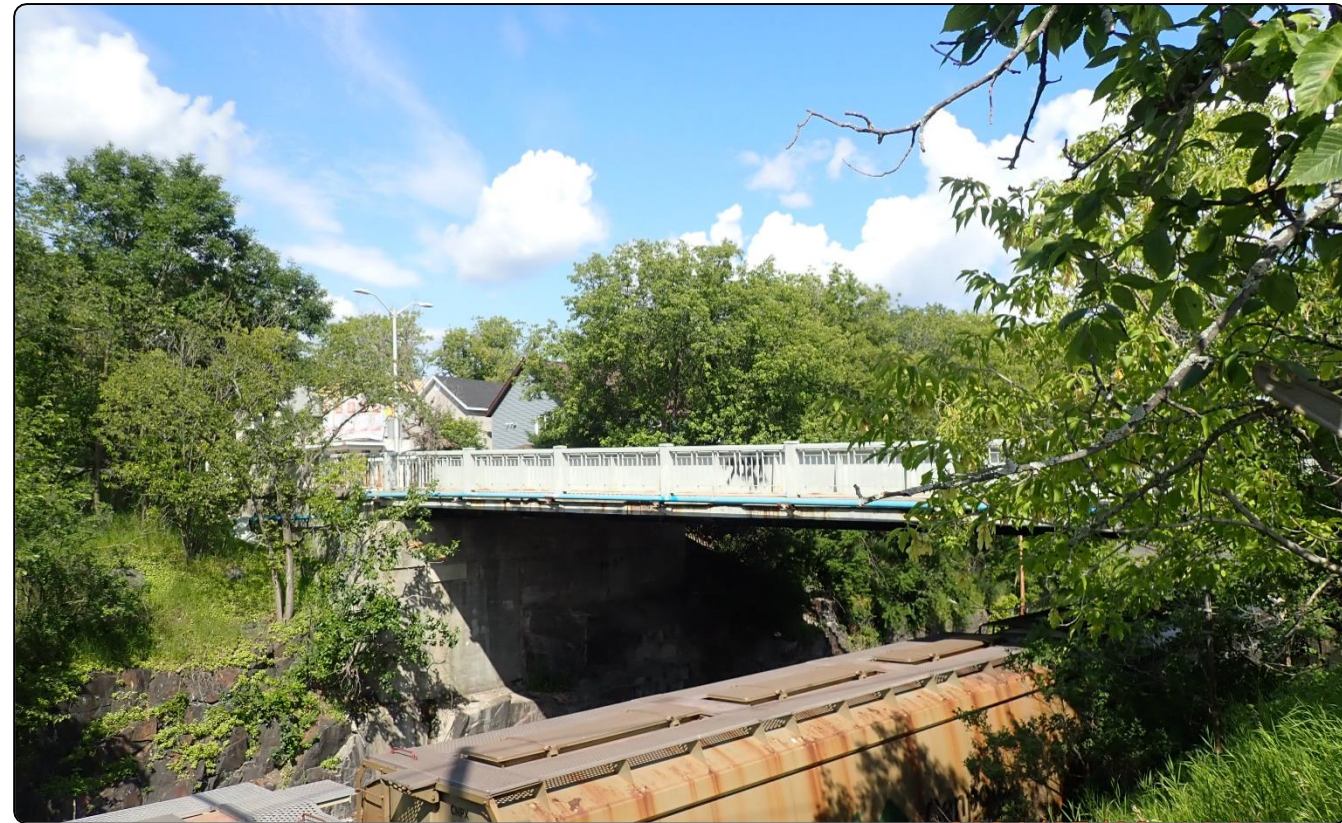
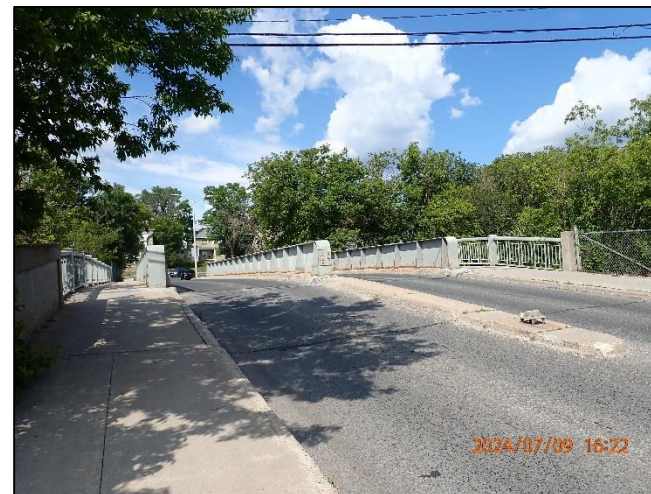
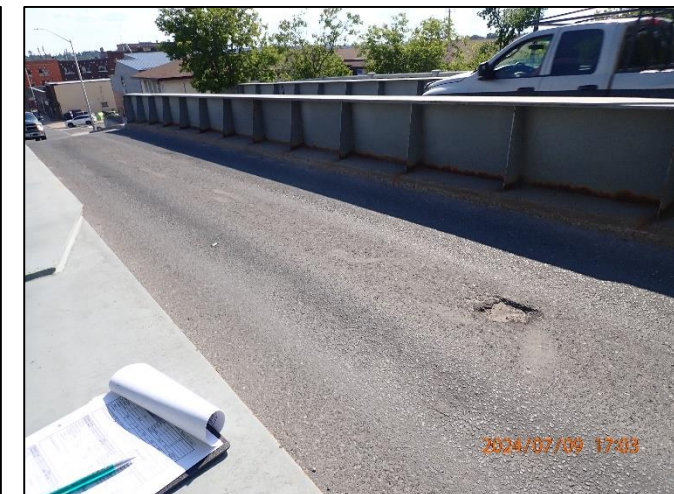
MATHESON STREET BRIDGE

- Abutment – Bearings (previous enhanced OSIM)
 - Disintegration of grout pads
- Accessories – Signs – South approach
 - Missing 'Keep Right' sign and beacon
- Accessories – Electrical – South approach
 - Missing light pole
- Approach & Deck – Wearing Surfaces
 - Isolated potholes and severe wheel path rutting
- Embankments
 - Overgrown vegetation encroaching structure

**Complete
Maintenance**

\$36,900

Recommend increasing enhanced inspections to every 4 years to monitor bearing condition

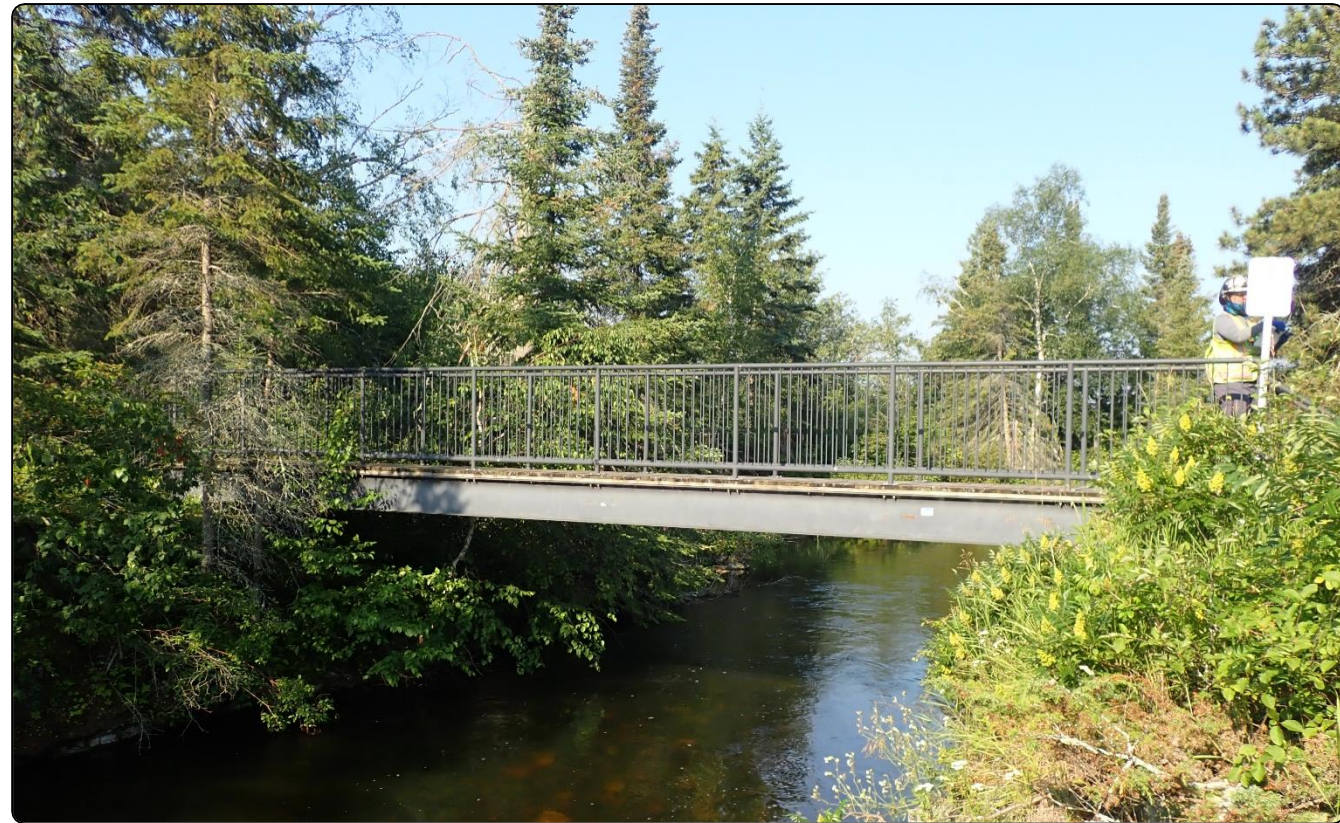
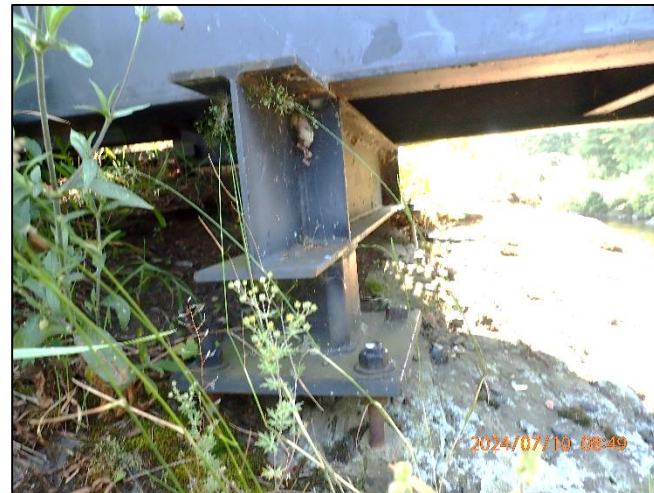
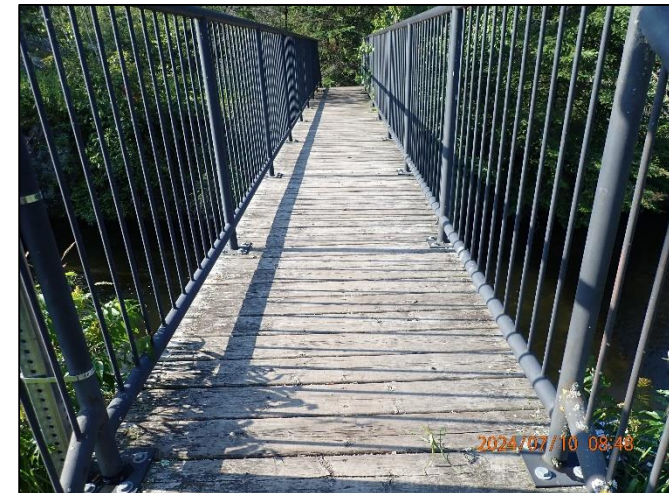
MINK BAY PEDESTRIAN BRIDGE

- Abutment - North
 - Slight movement and bending of anchor bolts due to expansion

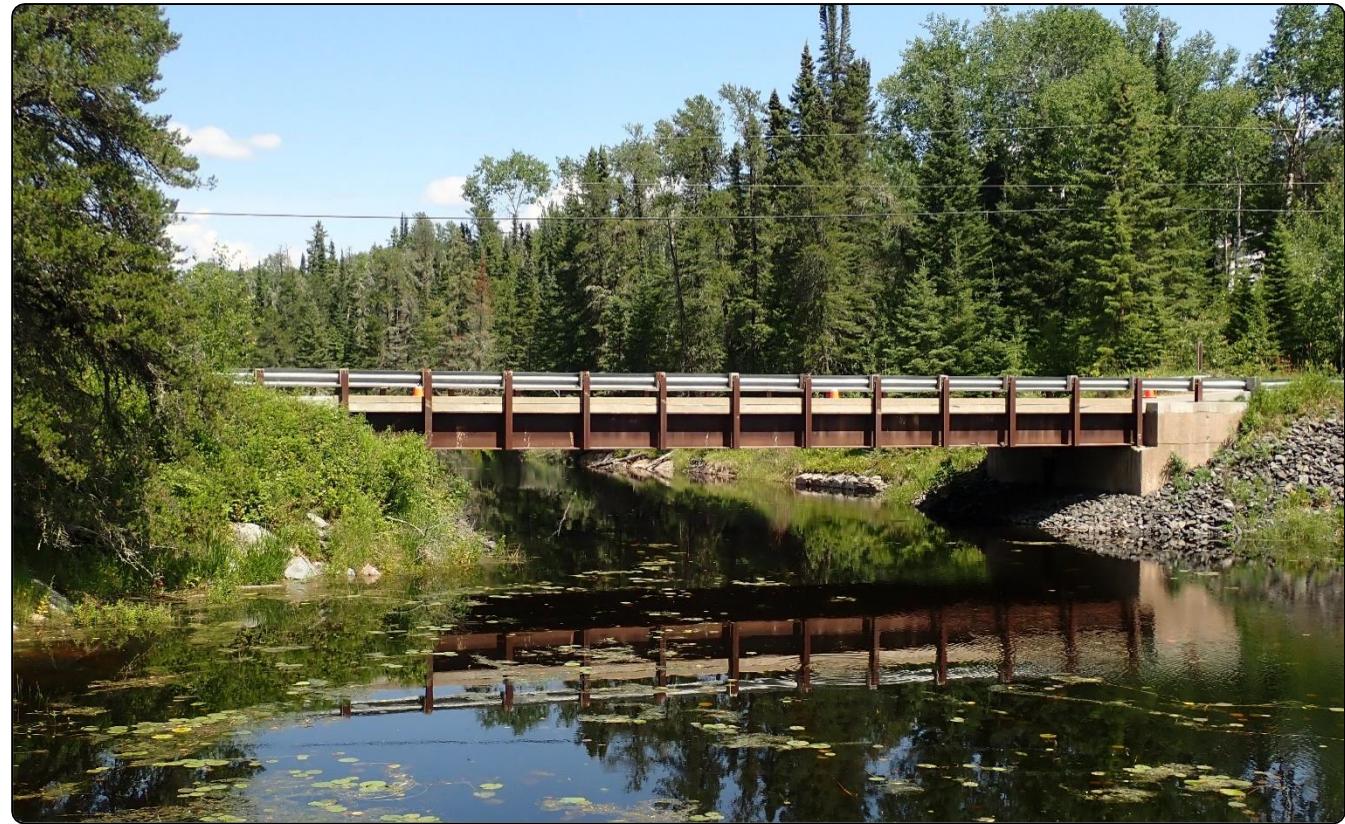
NORLEN BRIDGE

- Abutment & Ballast Walls
 - Delamination and spalls exposing corroded reinforcement
- Deck Soffit
 - Isolated delaminations and spalls

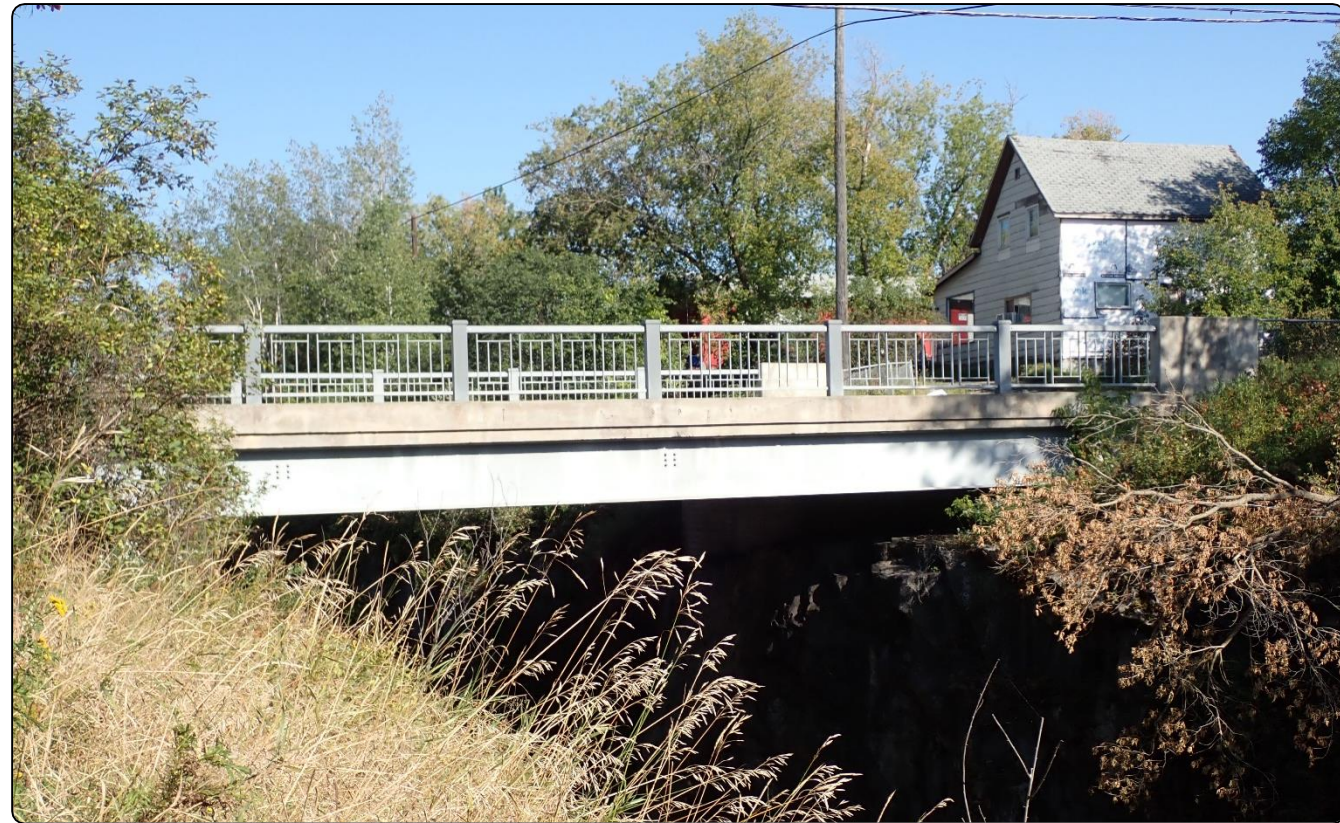
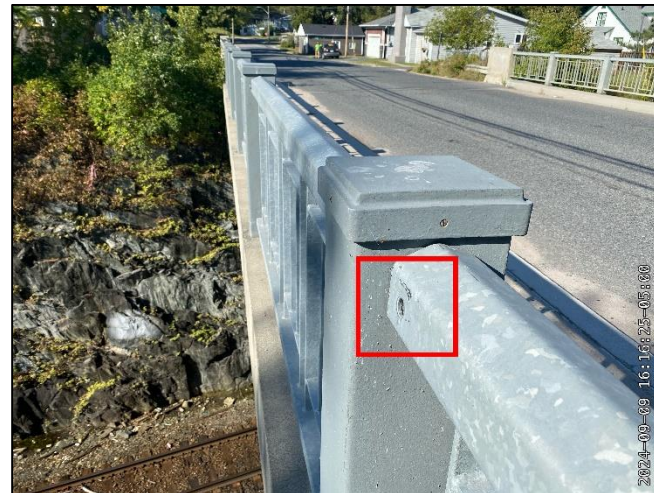
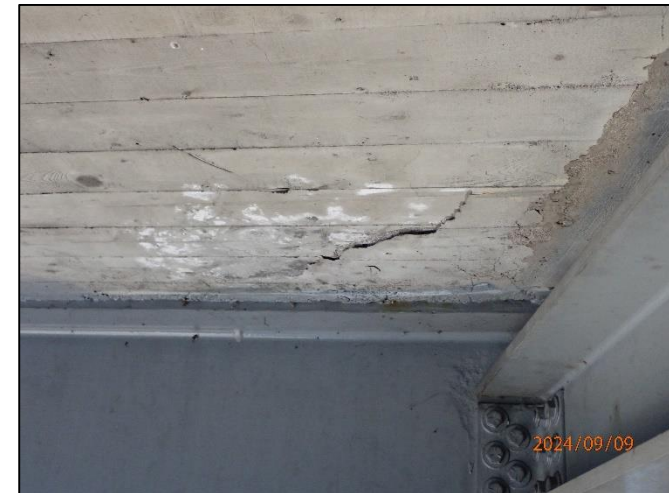
PARSON STREET BRIDGE

- Abutment – Ballast Wall
 - Disintegration exposing corroded reinforcement
- Barriers – Railing Systems
 - Missing bolt on West barrier
- Embankments
 - Overgrown vegetation encroaching structure and NE roadway
- Deck - Soffit
 - Leachate, severe delaminations, spalls, severe scaling exposing corroded reinforcement, and medium cracks

Complete Maintenance

\$47,500

Recommend detailed deck condition survey

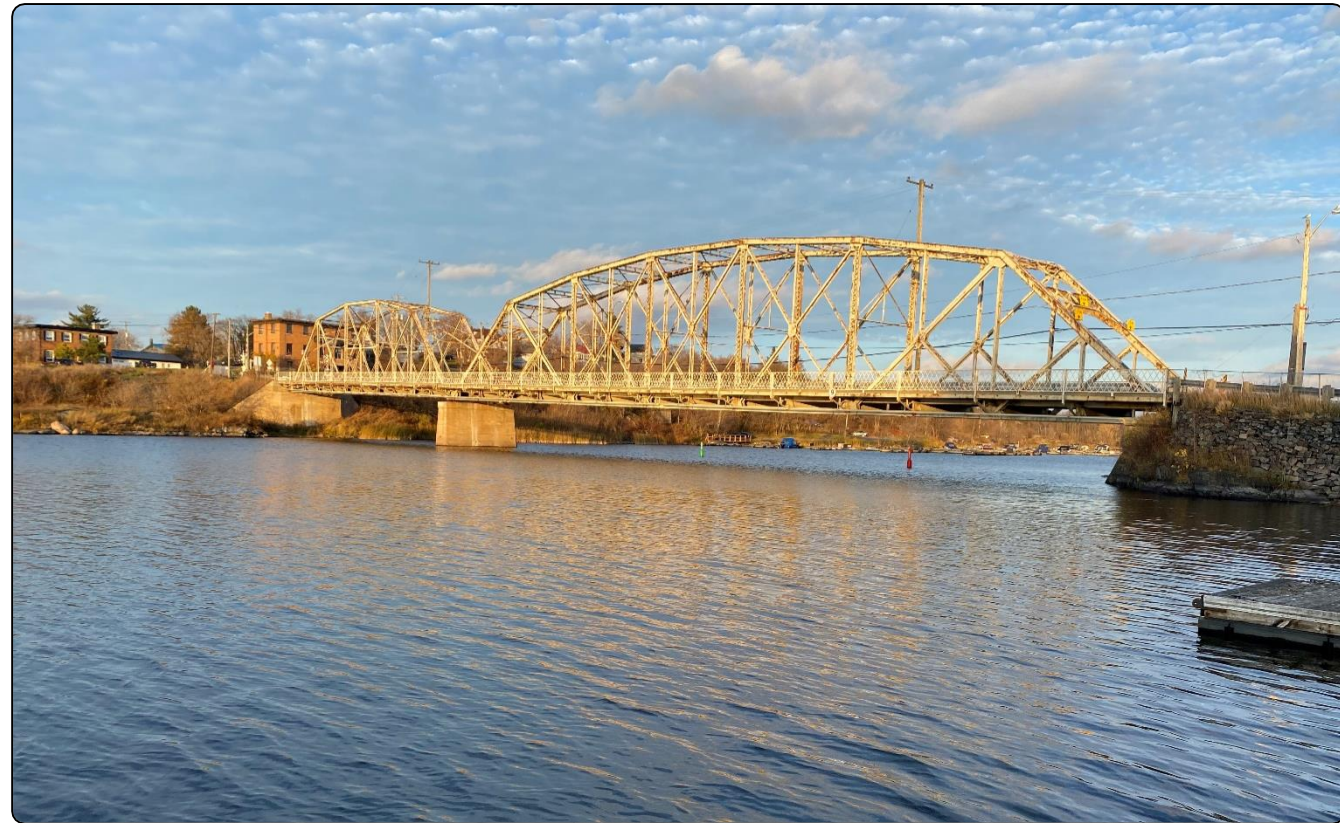
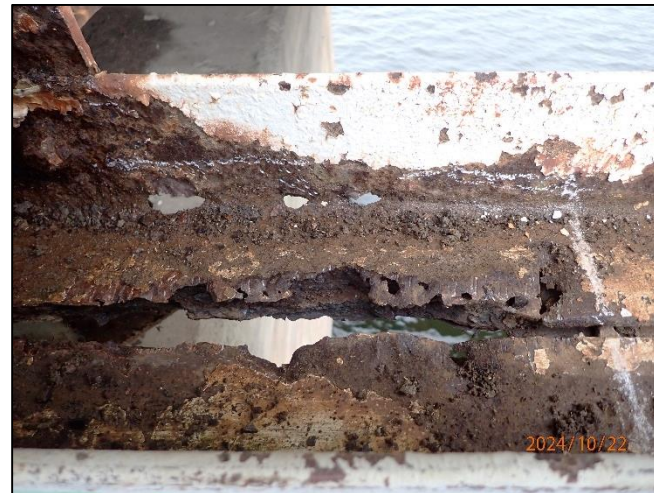
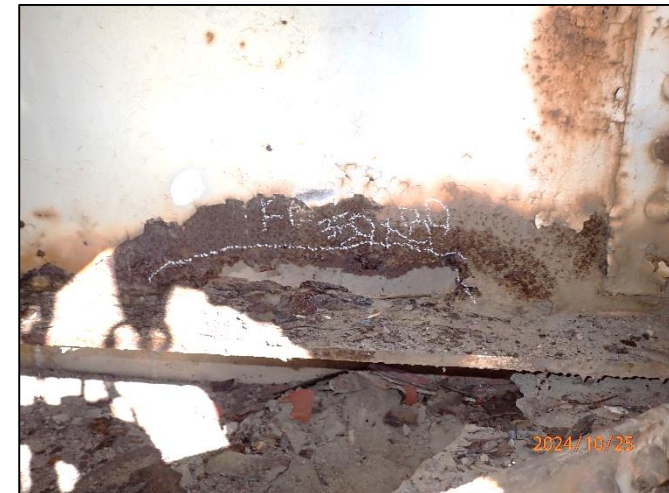
PORTAGE BAY BRIDGE

- Barriers - Posts
 - Isolated loose connection bolts to railing
- Embankments
 - Heavy vegetation growth
- Joints
 - Very severe spall at Abutment 2 end dam leaking water onto abutment. Joints filled with debris
- Pier – Bearings – Pier 1, Span 1
 - Broken anchor bolt on B1
- Truss
 - Loose and missing rivets throughout
 - Severe corrosion and perforations in bottom chords, gusset plates, bracing, and floorbeams

Maintenance

\$430,500

Rehabilitation

\$5.98

Recommend bridge closure due to perforations in lower chord
Recommend Substructure Condition Survey & Structure Evaluation
