2024 Inspection Summary

City of Kenora Bridges	BCI	City of Kenora Bridges	BCI
Bay Street Overpass	60.46	Matheson Street Bridge	70.39
Beggs Road Timber Bridge	69.68	Mink Bay Pedestrian Bridge	88.77
Beggs Road Arch Culvert	88.47	Norlen Bridge	86.91
Cameron Bay Bridge	81.99	Parson Street Bridge	68.27
Coker Road Bailey Bridge	98.42	Portage Bay Bridge	64.48
CPR Pedestrian Bridge	77.99	Portage Bay Walkway Bridge	71.39
Darlington Bay Bridge	75.07	Portier Bridge	72.75
Eighth Avenue Bridge	79.15	Seventh Avenue South Bridge	97.18
First Avenue Bridge	72.36	Winnipeg River East Branch Bridge	84.04
Keewatin Channel Bridge	70.85	Winnipeg River West Branch Bridge	73.53
Lajeunesse Bridge	71.19

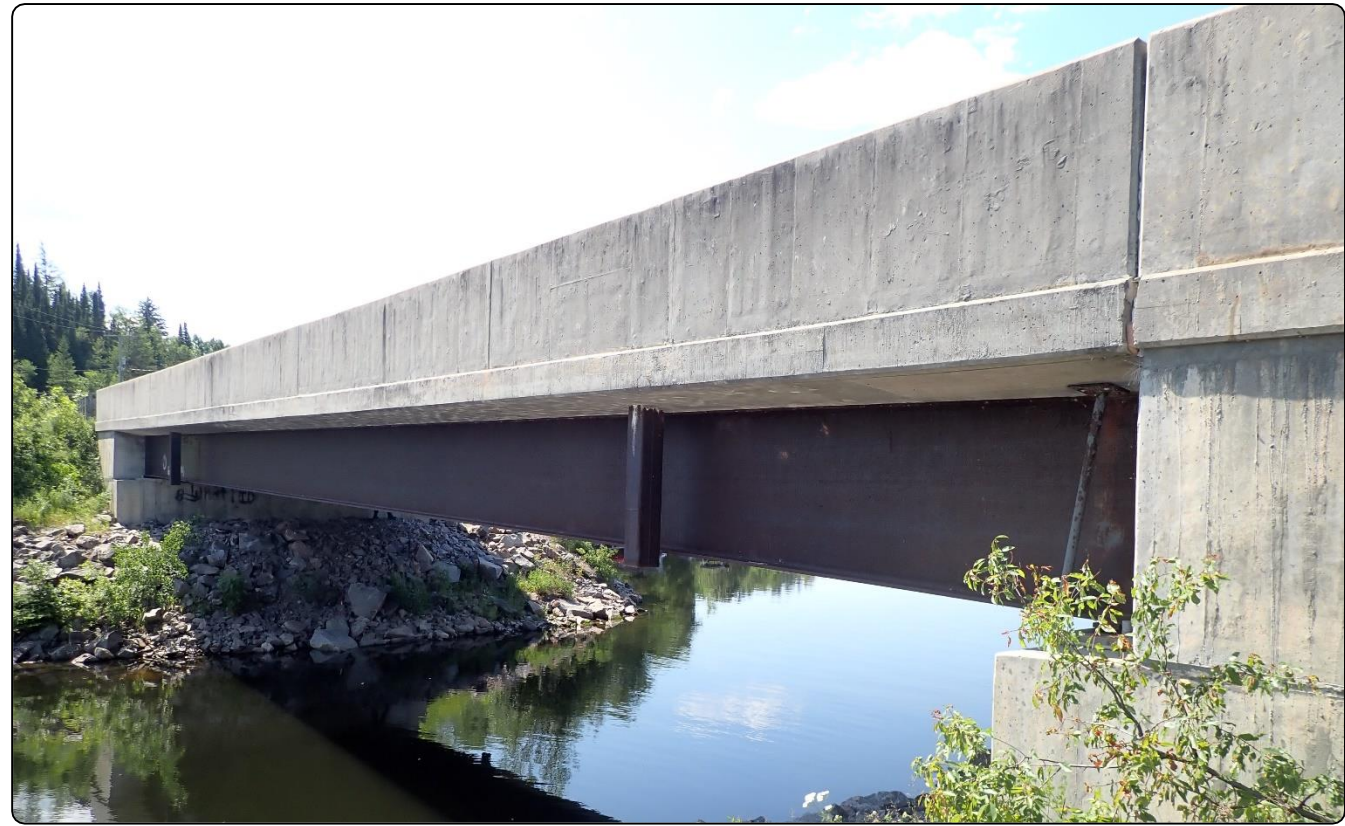
PORTIER BRIDGE

- Joints
 - Gravel filled joints
- Approaches – Wearing Surface
 - Isolated vegetation growth along interior barrier

**Complete
Maintenance**

\$3,200

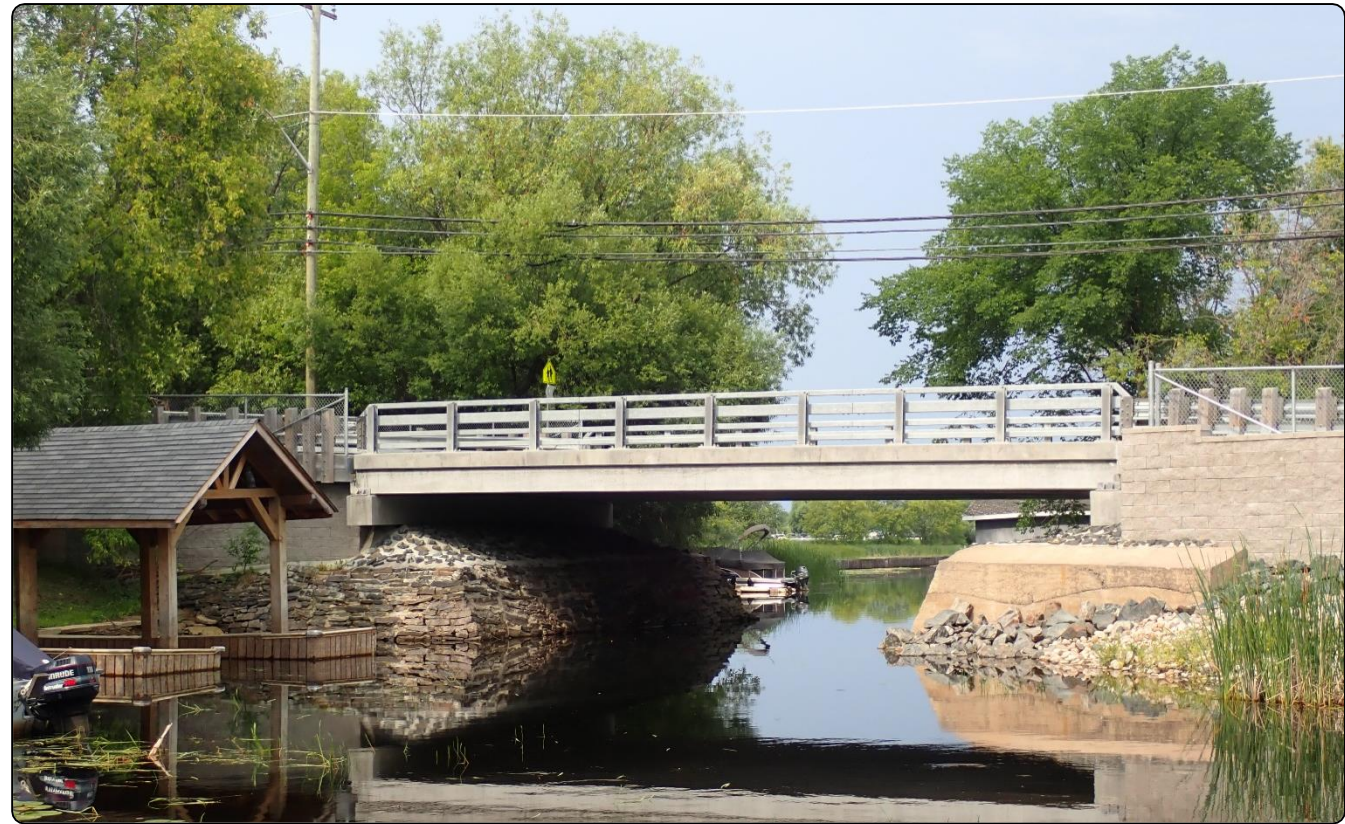
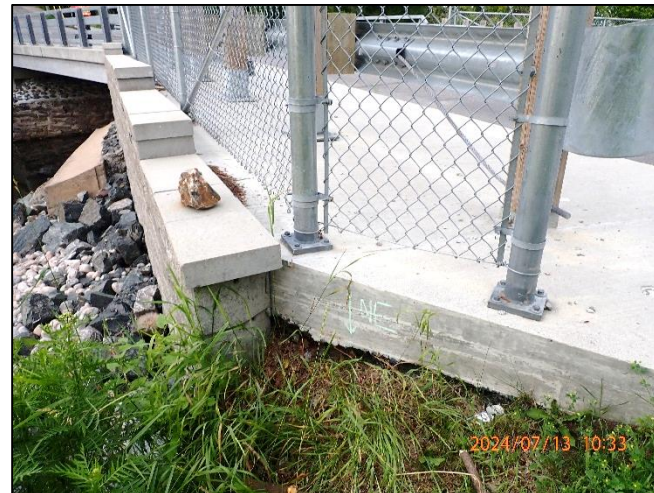
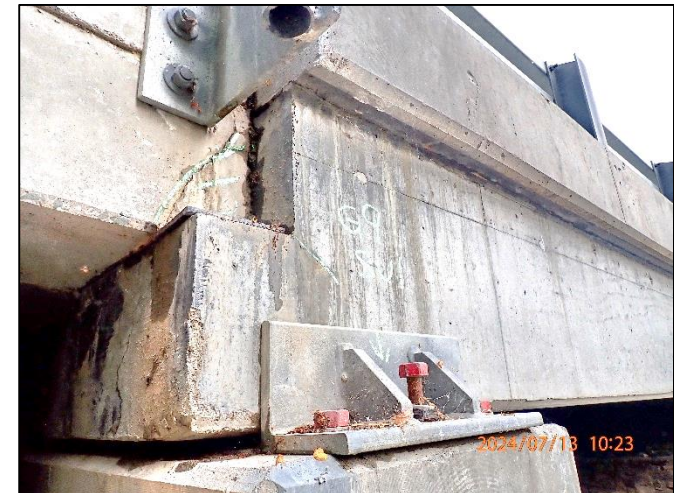
SEVENTH AVENUE SOUTH BRIDGE

- Embankments
 - Slight settlement with undermining along NE sidewalk
 - Excessive used needles found in front of abutments
- Abutment - Bearings
 - 1 of 3 anchor bolts at Abutment 1 West and East sides retainer plates is not tight.
- Joints - Sealant
 - Evidence of leaking onto Abutment 1 West side

Complete
Maintenance

\$8,100

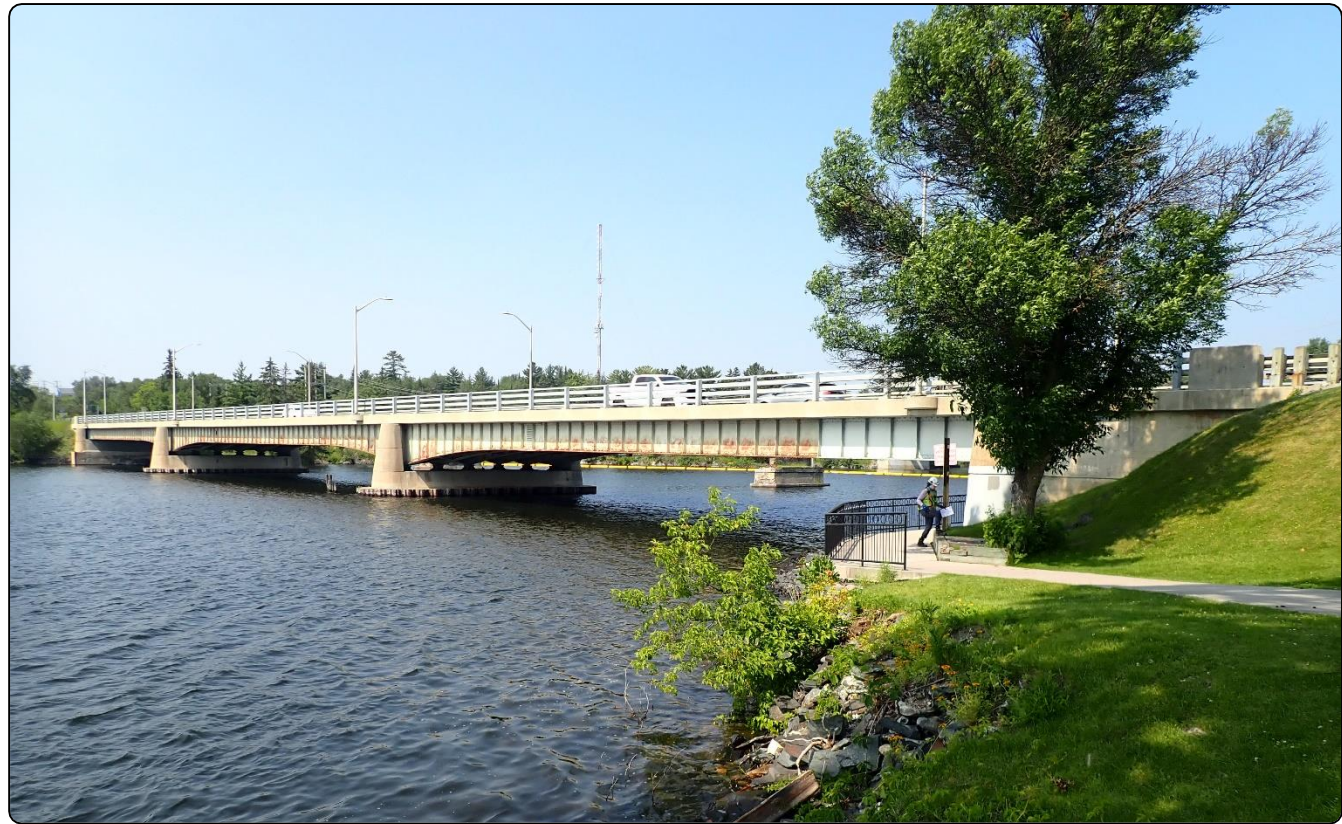
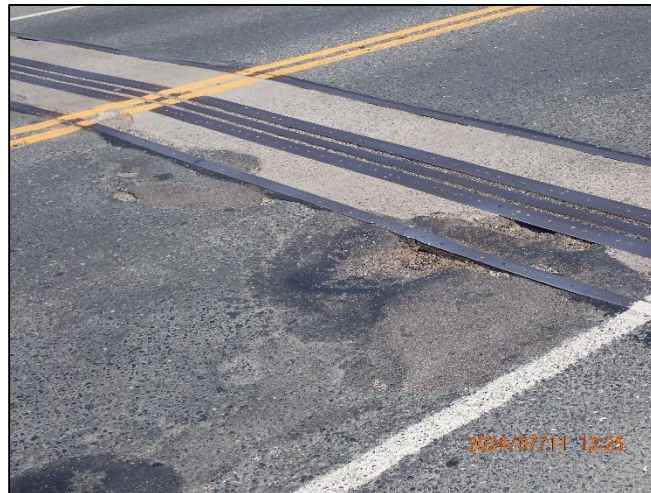
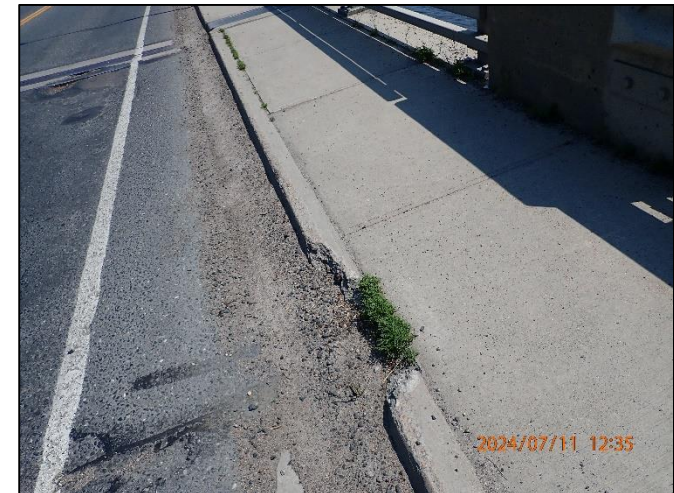
WINNIPEG RIVER EAST BRANCH BRIDGE

- Accessories - Utilities
 - Separated conduit with exposed wires
- Approaches – Wearing Surface
 - Severe pothole at Joint 1
- Approaches - Sidewalk
 - Very severe spall exposing corroded reinforcement on SW sidewalk
- Barriers - Railing
 - Several missing bolt connections to posts
- Joints
 - Armouring is missing 6 bolts at Joint 1
 - Severe spalls in Joint 1 End Dam
 - Joints filled with debris

**Complete
Maintenance**

\$15,000

Recommend Detailed Deck Condition Survey - Soffit condition

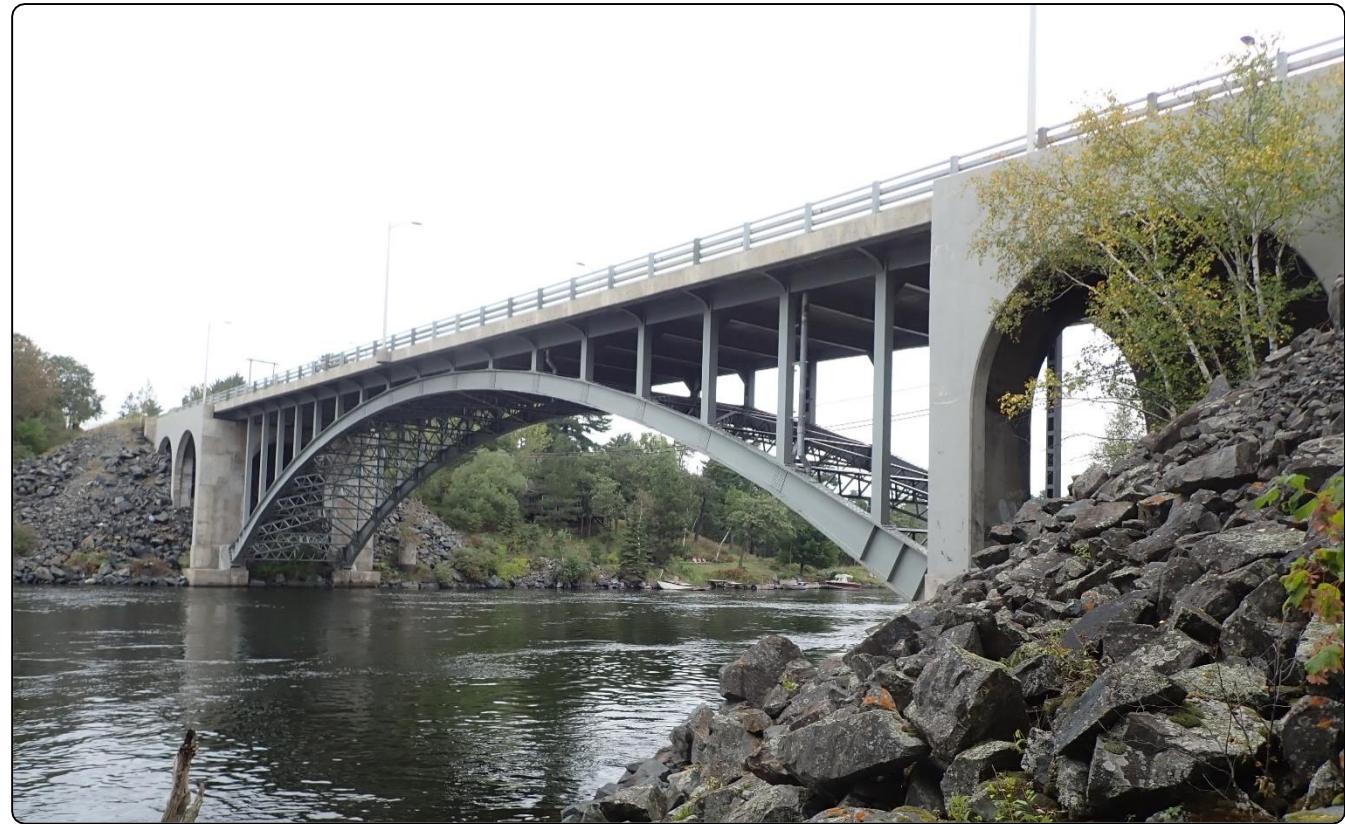
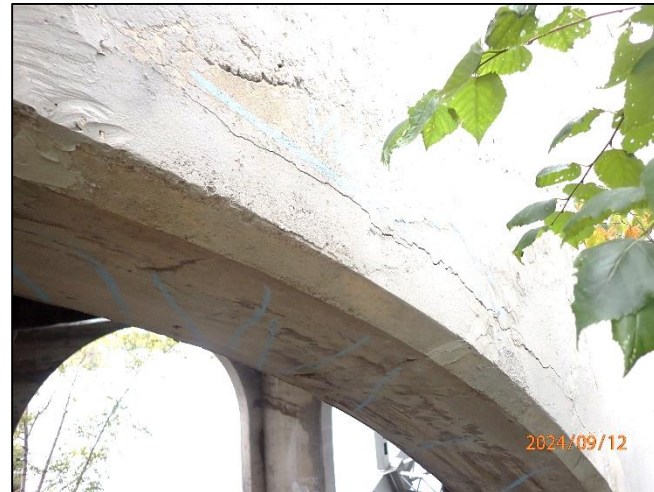
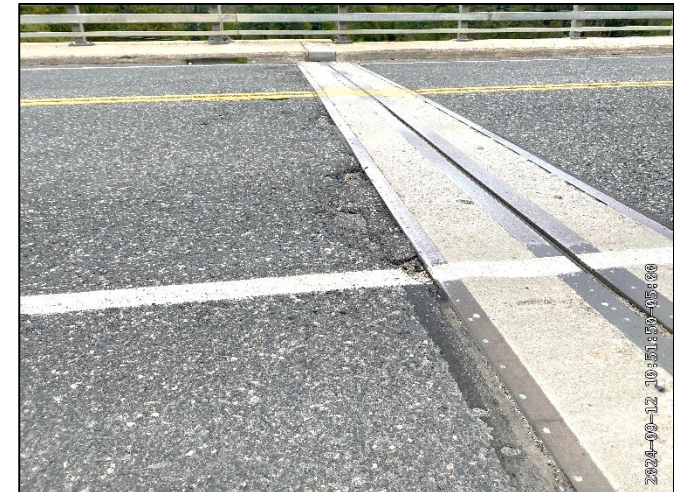
WINNIPEG RIVER WEST BRANCH BRIDGE

- Accessories - Utilities
 - NW light pole has an open panel
- Approaches & Deck – Wearing Surface
 - Severe pothole and crack at Approach 1
 - Severe potholes and delaminations at Joint 1 with 40mm differential
- Approaches - Sidewalk
 - 25mm elevation differential at Abutment 2
- Barriers – Railing – Deck & Approaches
 - Several missing bolt connections to posts and newel
- Joints
 - Armouring is missing a section above Pier 3
 - Joints filled with gravel

Complete Maintenance

\$22,600

Recommend monitoring stringers and spandrel arch's cracks in concrete

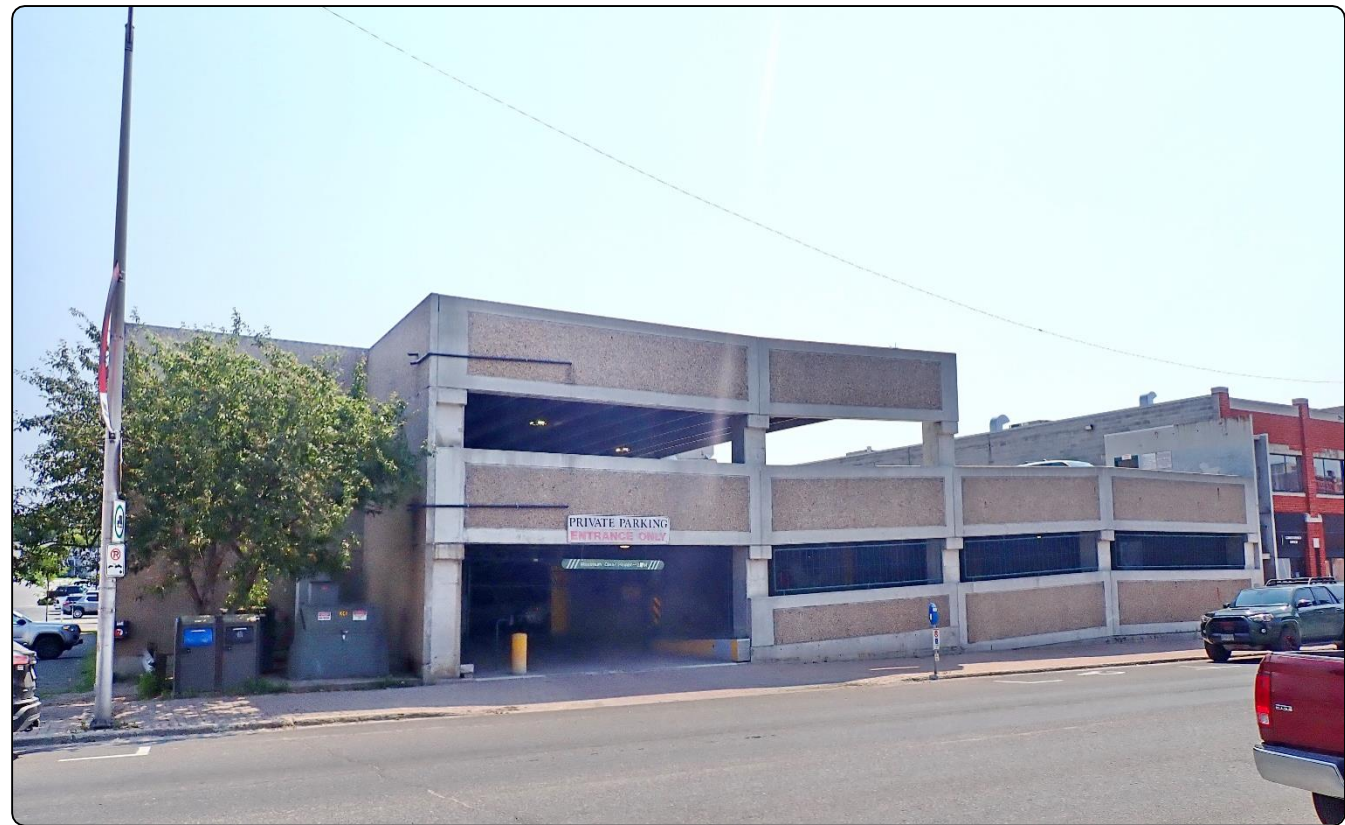
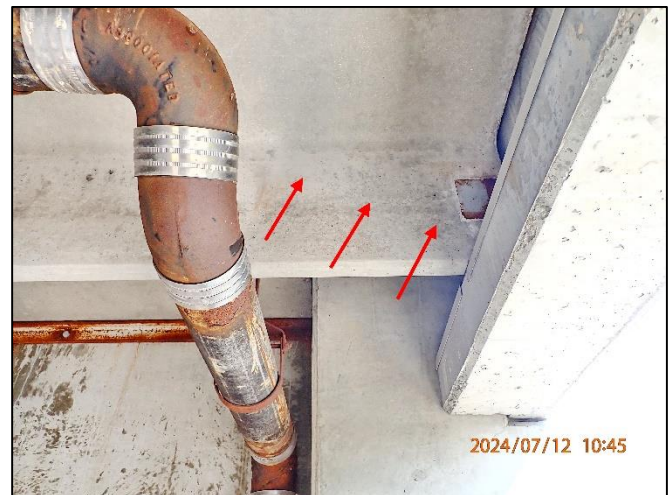
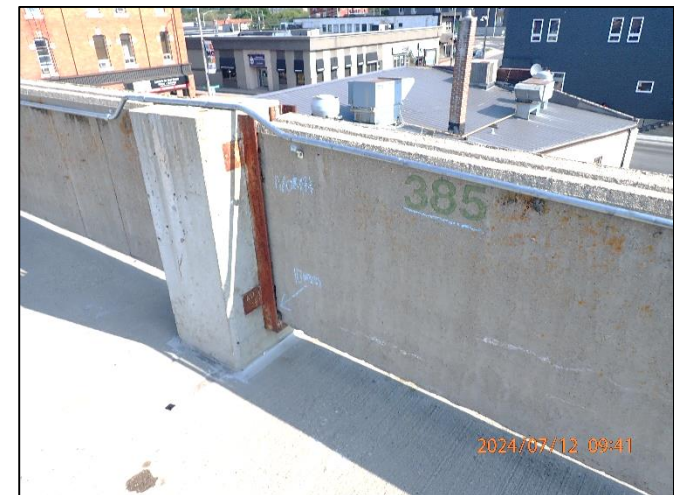
KENORA PARKADE

- Accessories - Utilities
 - Utilities: Several Luminaires not functioning
 - Signs: One 'Reserved Parking' sign is illegible
- Stairwells
 - Grout packing is falling out and several non-functioning lights
 - 1st level concrete entry pad could cause tripping hazard
- Barriers
 - Hollowcore has 10mm remaining bearing at parking #385
 - Deformation of steel barrier at NE corner
- Columns
 - Delaminated concrete spalling onto sidewalk below
- Wearing Surface
 - Extensive used needles and paraphernalia throughout
 - Several areas of settlement and missing paving stones
- Beams – Double-T section
 - Hairline to narrow shear cracks on select girders throughout

Complete Maintenance	\$46,700
---------------------------------	-----------------

Recommend Detailed Deck Condition & Substructure Surveys, Structure Evaluation, and monitoring girder crack widths

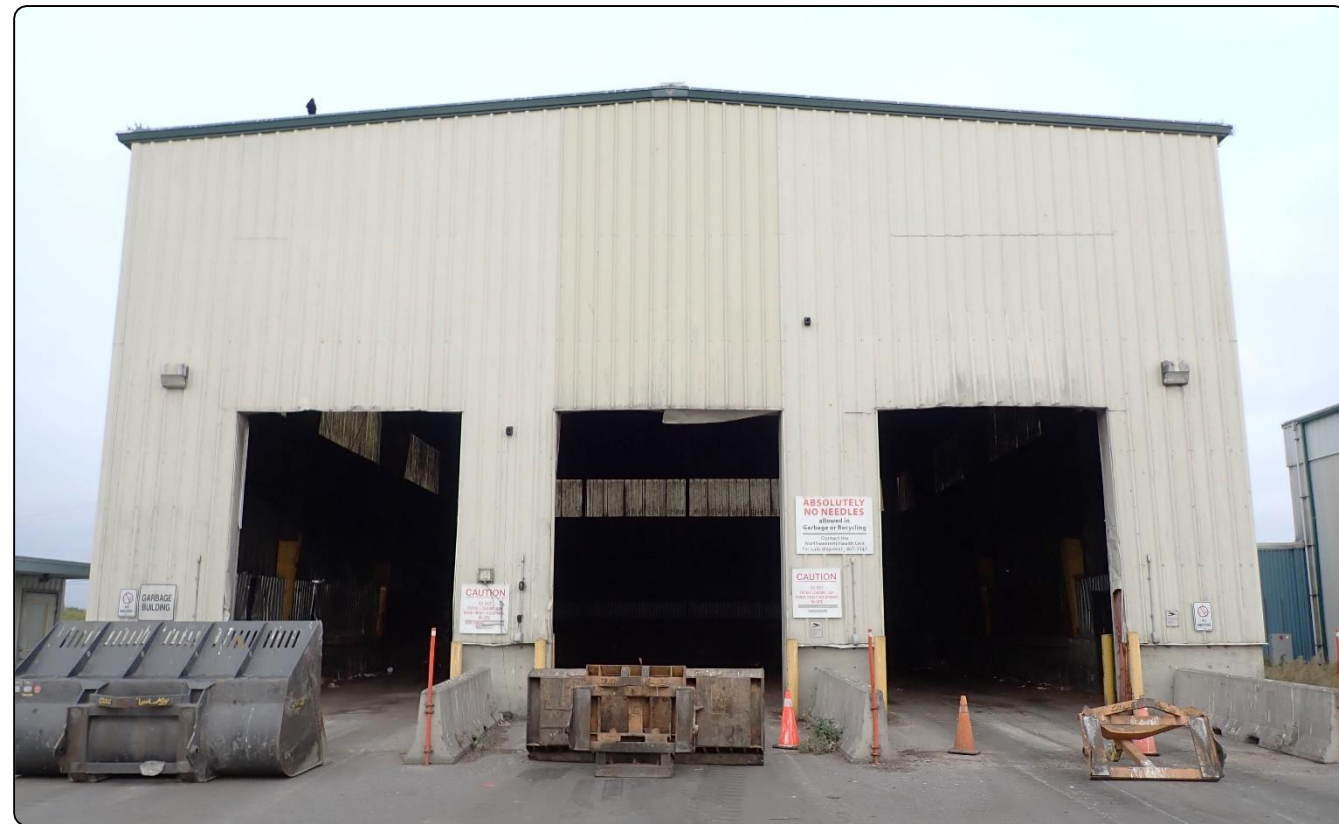
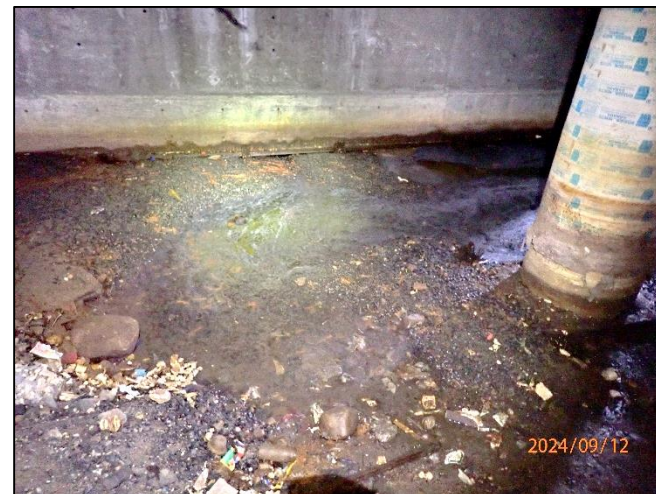
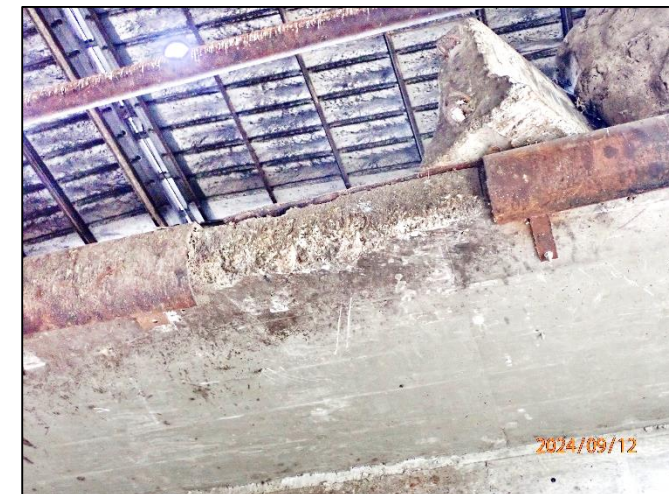
WASTE TRANSFER STATION

- Walls - Exterior
 - Severe spall exposing corroded reinforcement on South wall
- Walls – Substructure Interior
 - Large amount of standing water in SW corner
- Joints - Armouring
 - Missing section of plate

Multiple rigid frame columns have been dented and deformed

Complete Maintenance	\$9,500
---------------------------------	----------------
