2024 Inspection Summary

City of Kenora Bridges	BCI	City of Kenora Bridges	BCI
Bay Street Overpass	60.46	Matheson Street Bridge	70.39
Beggs Road Timber Bridge	69.68	Mink Bay Pedestrian Bridge	88.77
Beggs Road Arch Culvert	88.47	Norlen Bridge	86.91
Cameron Bay Bridge	81.99	Parson Street Bridge	68.27
Coker Road Bailey Bridge	98.42	Portage Bay Bridge	64.48
CPR Pedestrian Bridge	77.99	Portage Bay Walkway Bridge	71.39
Darlington Bay Bridge	75.07	Portier Bridge	72.75
Eighth Avenue Bridge	79.15	Seventh Avenue South Bridge	97.18
First Avenue Bridge	72.36	Winnipeg River East Branch Bridge	84.04
Keewatin Channel Bridge	70.85	Winnipeg River West Branch Bridge	73.53
Lajeunesse Bridge	71.19

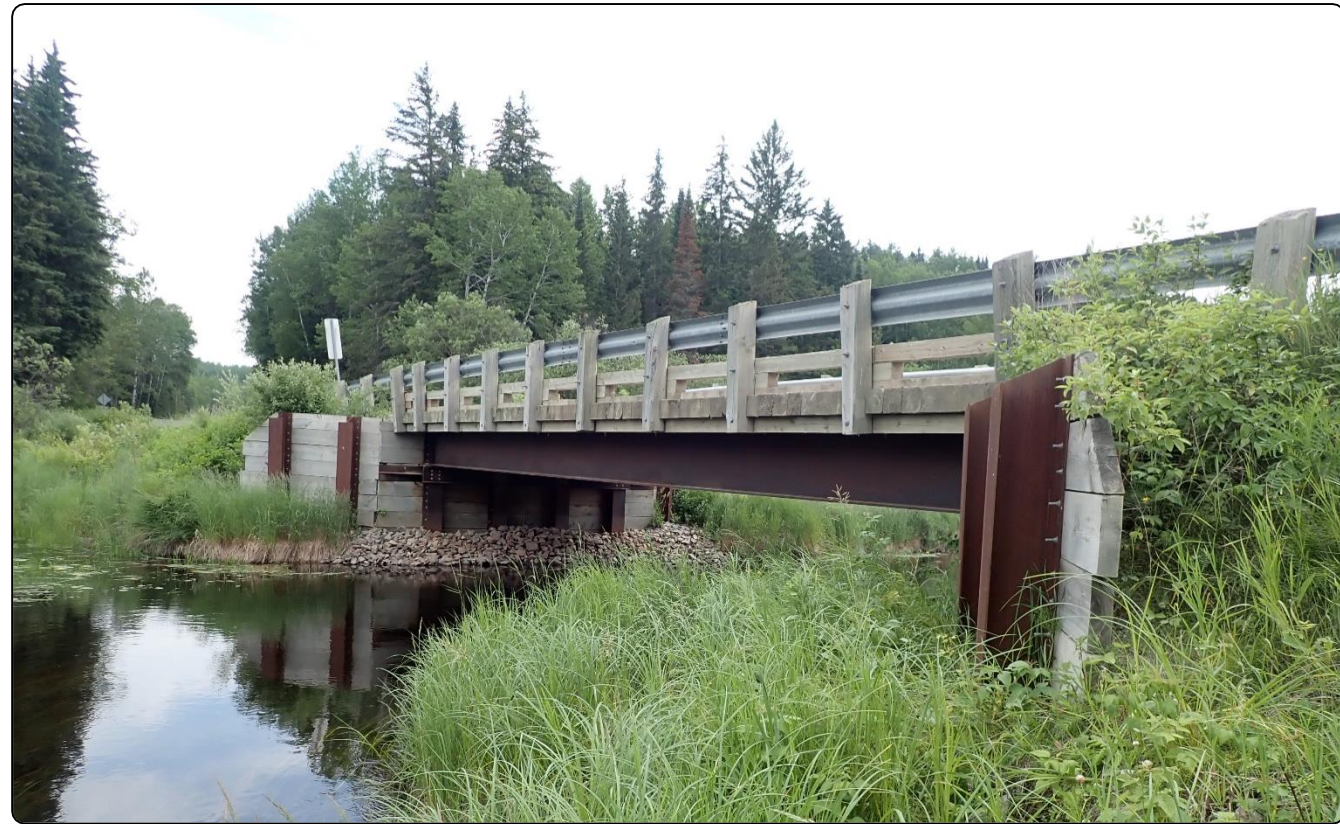
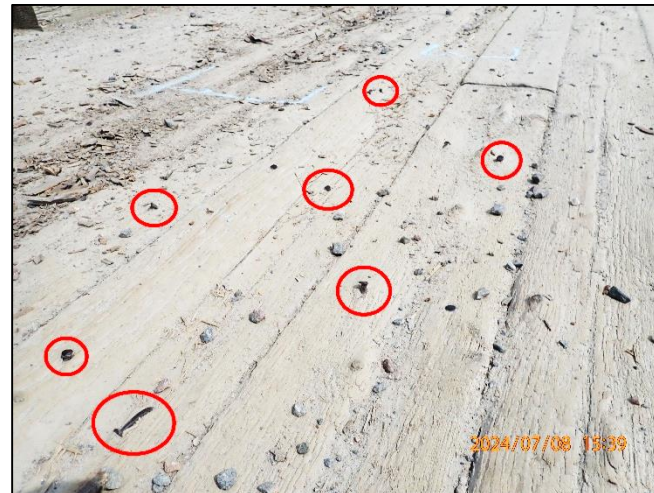
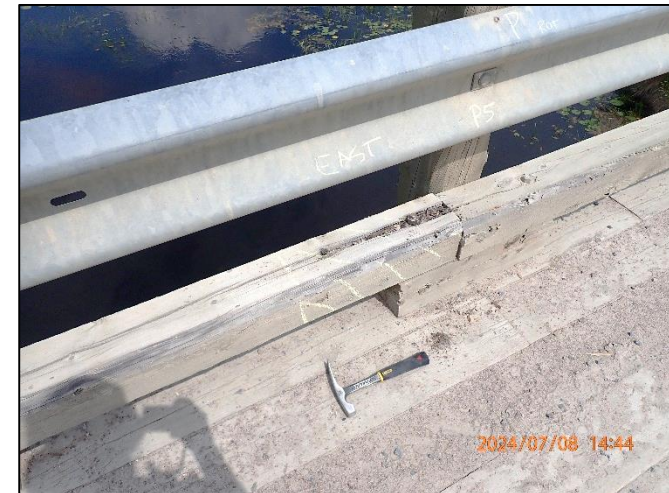
- Deck Wearing Surface
 - Severe wear and exposed nail heads
- Curbs
 - Isolated interior rot on East curb
- Approaches Wearing Surface
 - Severe wheel path rutting with potholes in gravel
- Foundations
 - Possible translation of piles causing gaps between abutment and wingwalls
 - No further movement measured from previous inspection

\$69,200

Monitor South Abutment Wall and Piles movement at next inspection

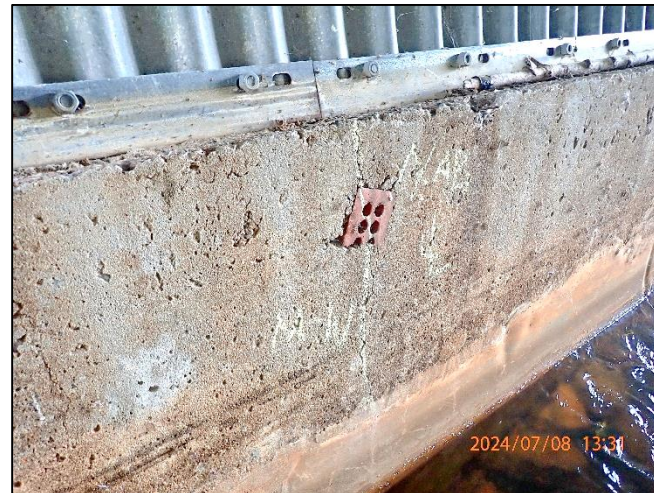
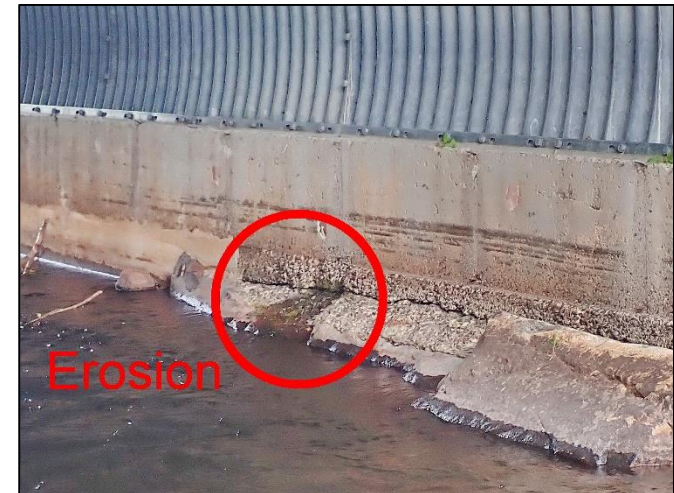
- Abutment Wall - North
 - Isolated vertical medium to wide crack at center of barrel
- Abutment Wall - South
 - Erosion and construction joint
- Culvert Barrel
 - Isolated deformation at inlet soffit

None

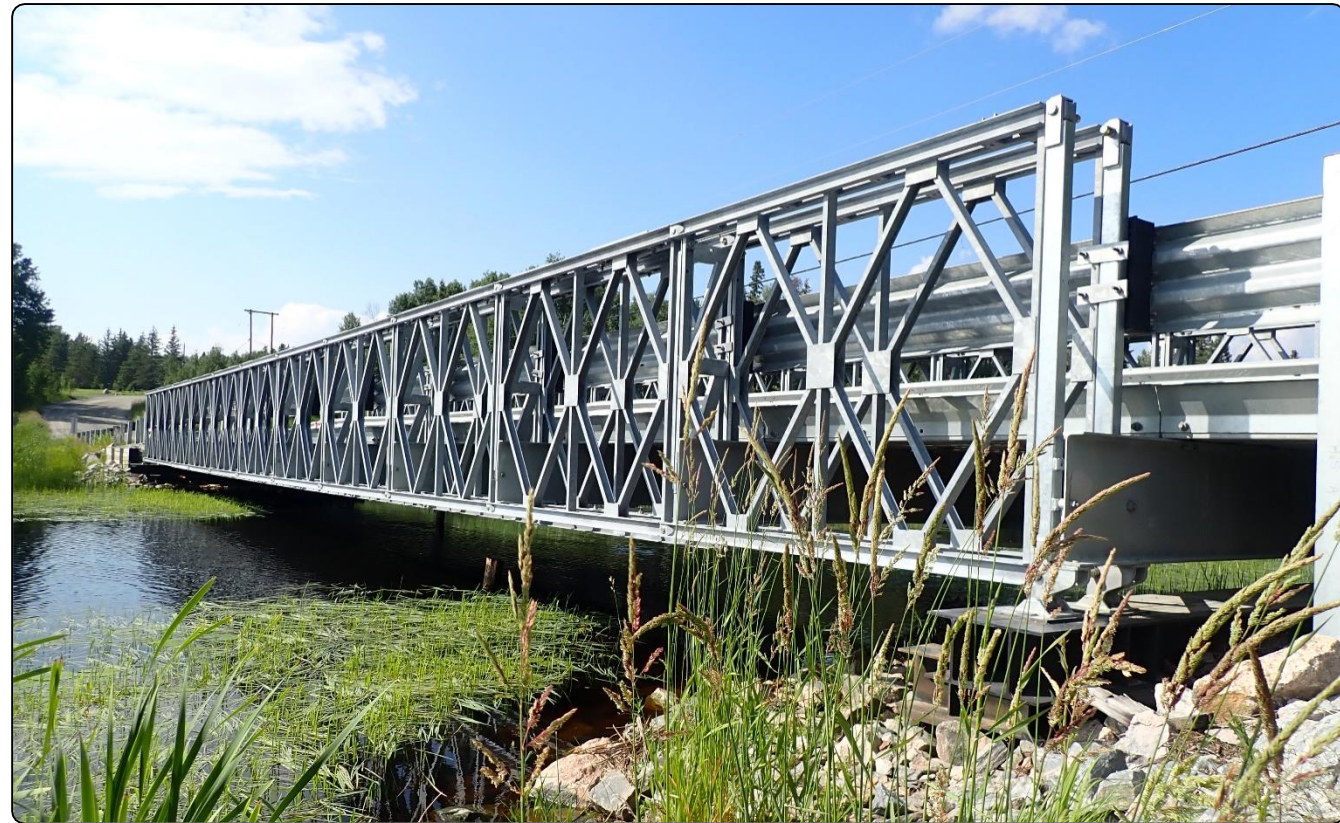
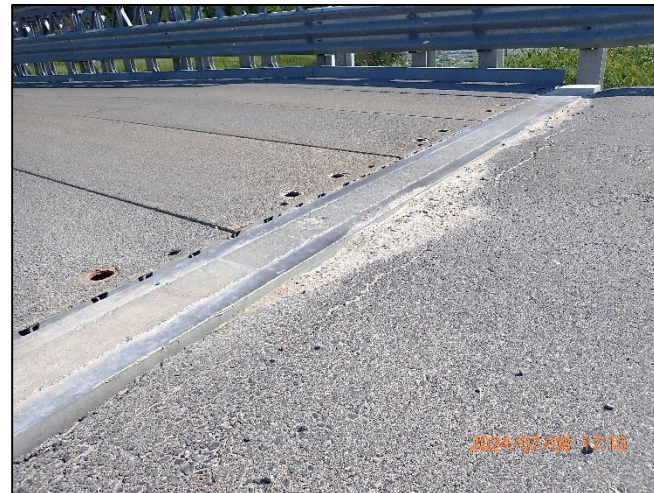
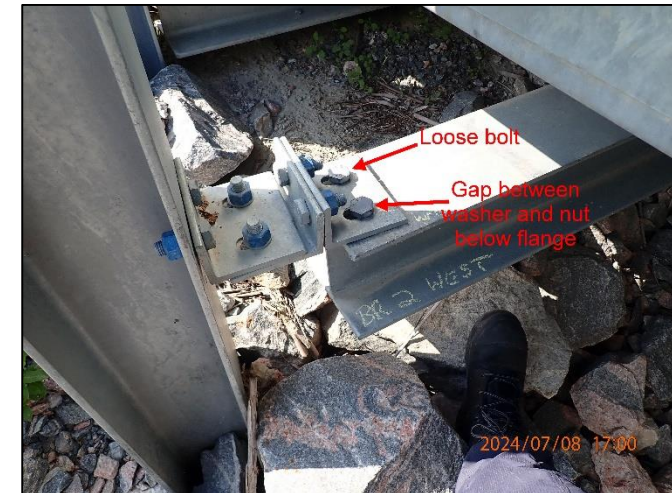
- Approach Wearing Surface - North
 - Up to 30mm depression along joint armouring (increase since previous inspection)
- Coatings – Structural Steel - Panels
 - Isolated peeling galvanizing
- Bracing – Under Deck
 - Loose connection to post on West side, fully expanded

Complete
Maintenance

\$3,000

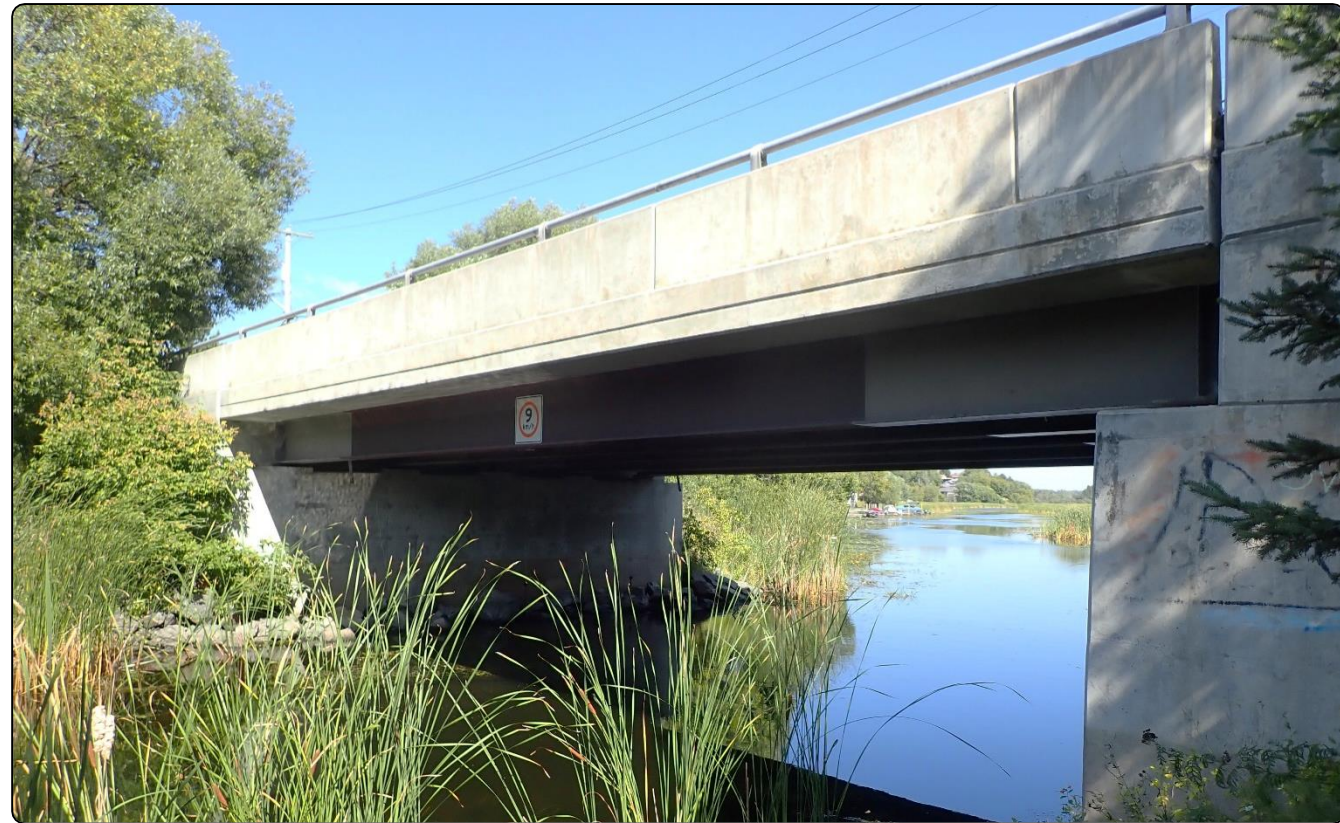
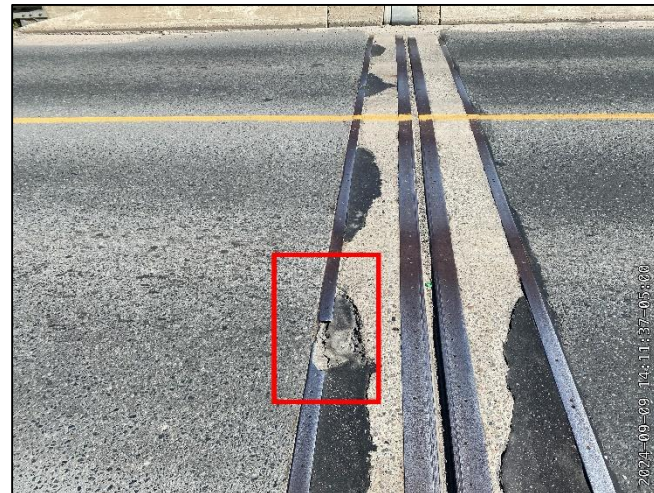
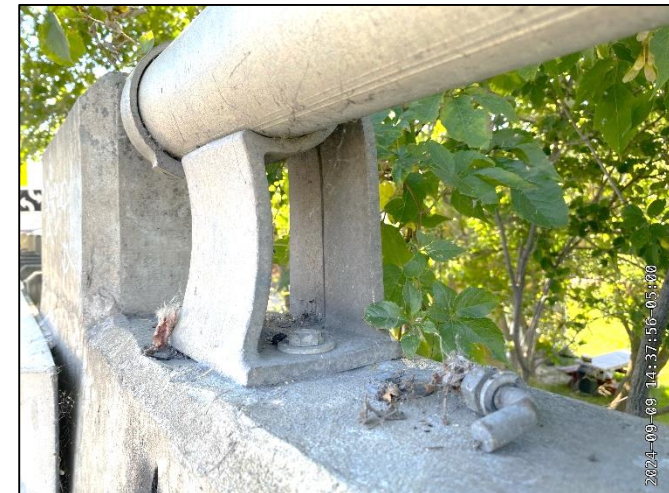
- Accessories – North Abutment
 - Missing light
- Barriers - Posts
 - Isolated missing bolts
- Embankments
 - Vegetation overgrowth encroaching bridge at all corners
- Joints
 - Isolated disintegration and spall exposing corroded reinforcement in end dams
 - Section of steel armouring missing at Abutment 2

**Complete
Maintenance**

\$24,500

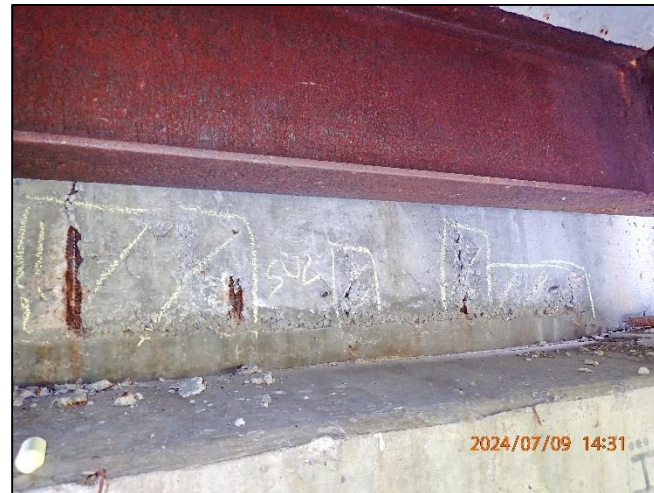
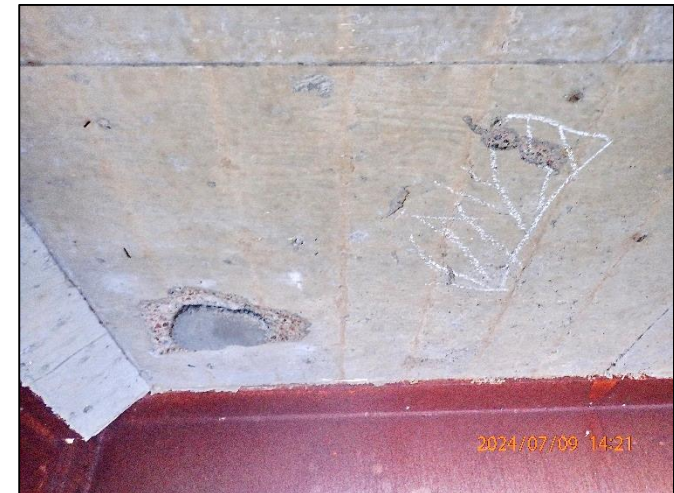
- Abutment & Ballast Walls
 - Delamination and spalls exposing corroded reinforcement
- Deck Soffit
 - Isolated delaminations and spalls

None
